Historical and Archaeological Investigations of a Sunken Federal Period Vessel near Oriental, North Carolina

Underwater Archaeology Branch
Division of Archives and History
North Carolina Department of Cultural Resources
Kure Beach, North Carolina
1992

A Thesis
Presented to the
Faculty of the Department of History
East Carolina University

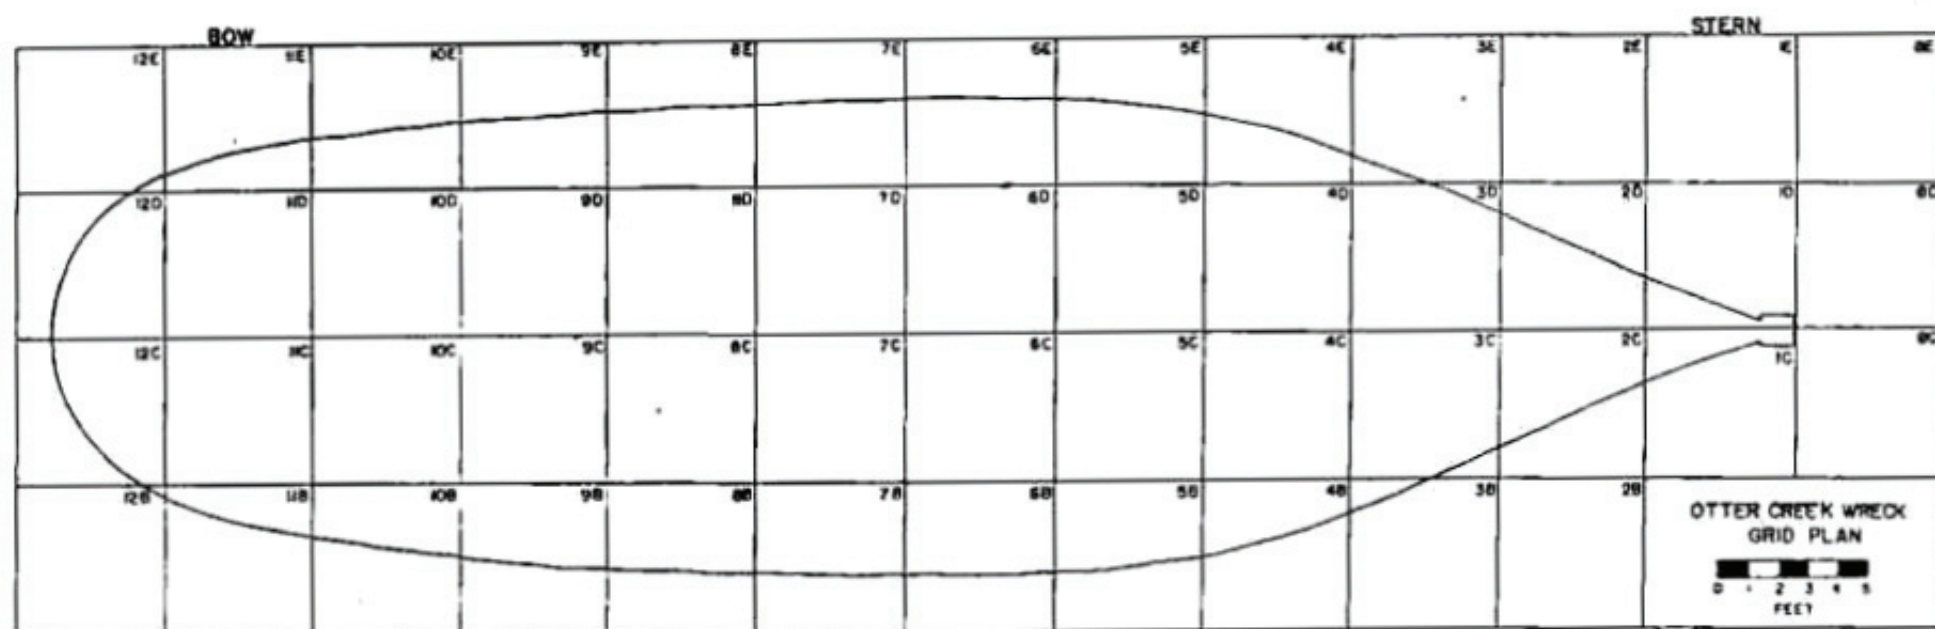
Figure 13. Excavation grid plan.

Thirty feet forward of the sternpost a secured perpendicular line crossed the keelson for the purpose of guiding an athwartship trench. The trench excavation began at the exposed futtock ends on the port side and worked toward the keelson. Once the port side excavation began a second dredge was employed to begin digging the athwartship trench from the starboard side. A Hale fire pump equipped to handle two 3-inch induction hoses would be used for

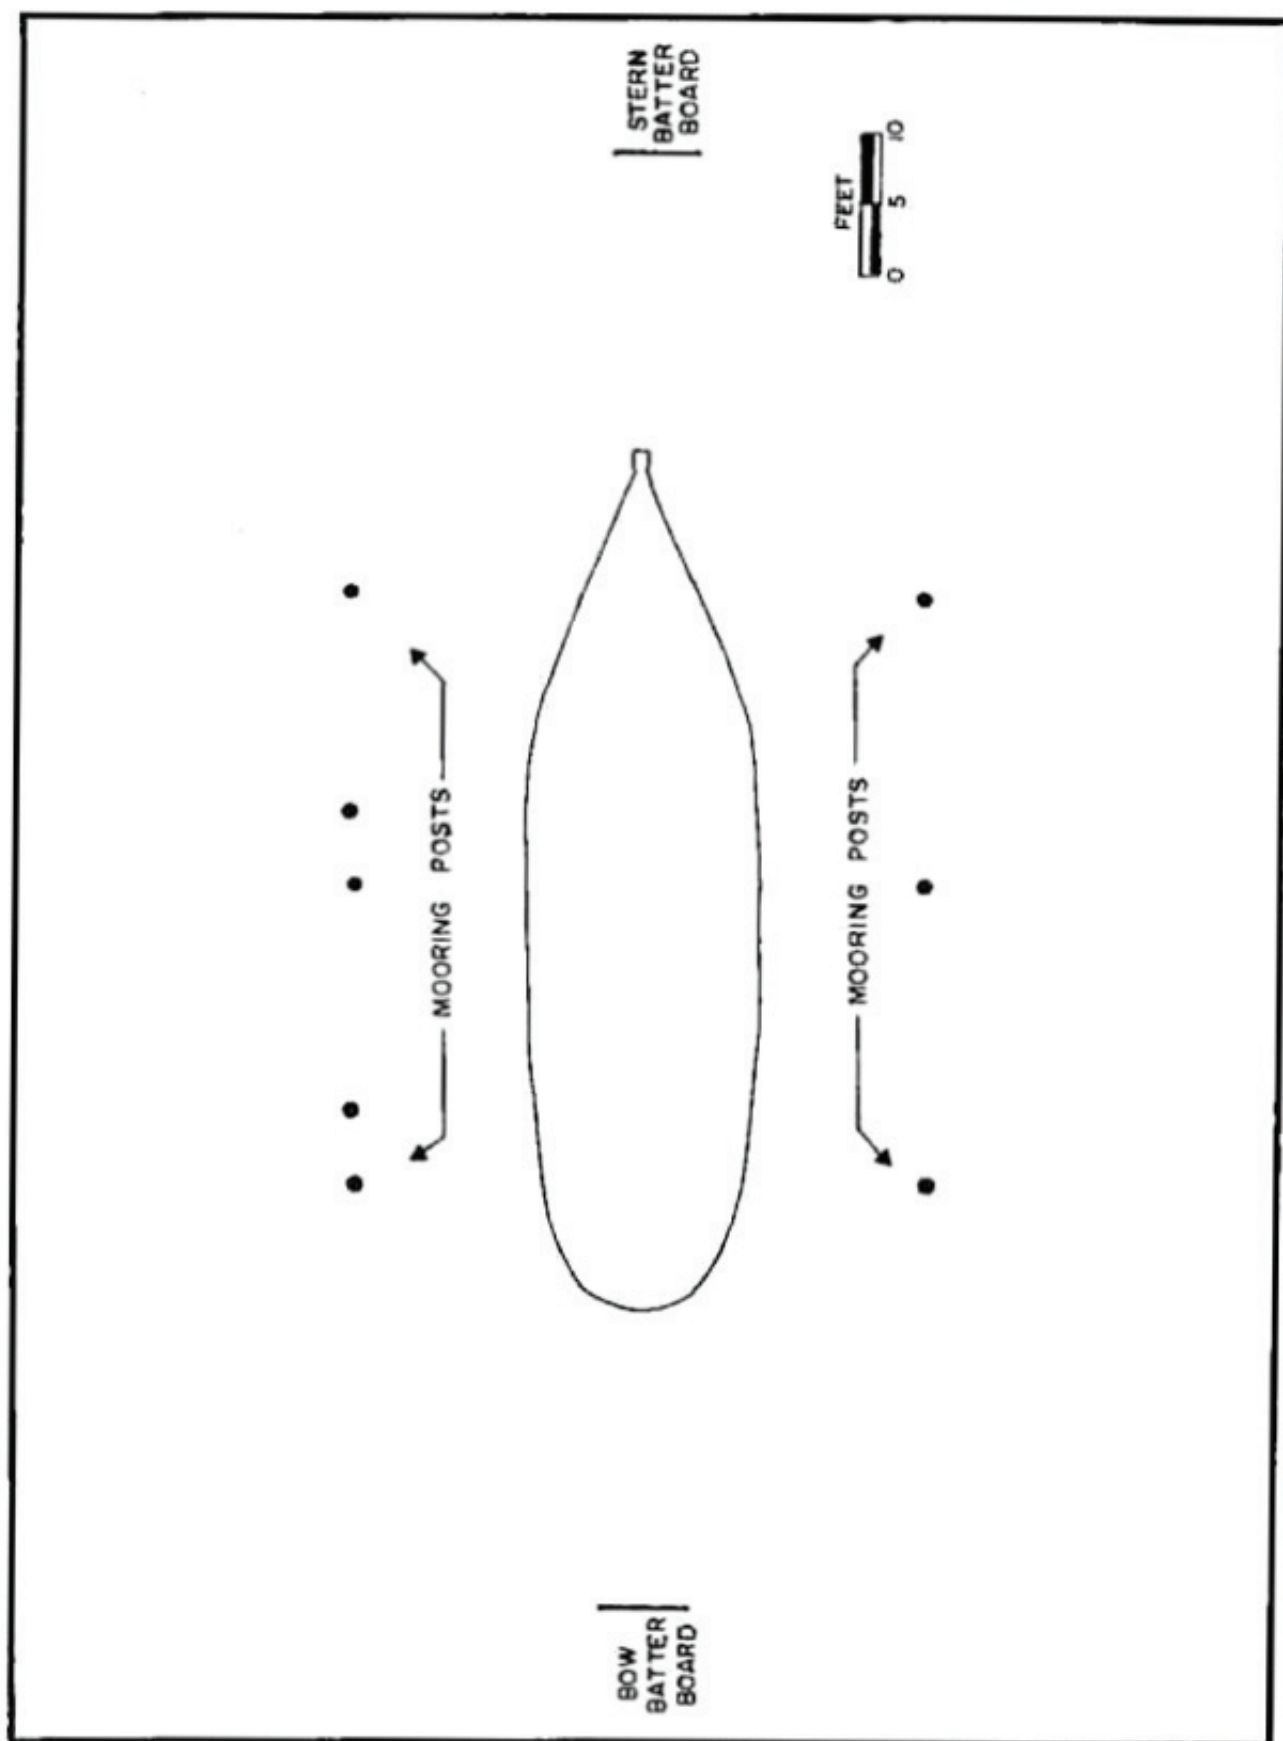
Figure 14. Location of batter boards and mooring posts.

The forward end of the keelson excavation trench continued until it revealed two breast hooks in the deteriorated bow section.¹⁸ The aft end of the keelson excavation trench proceeded past the mainmast step, the bilge pump wells, and the stern knee, finally reaching the sternpost. With the excavation trench proceeding in opposite directions two further fence posts had to be placed into the sediment twenty-five and forty-five feet forward of the stern on the starboard side to secure the dredge workboat near the wreck (Figure 14).

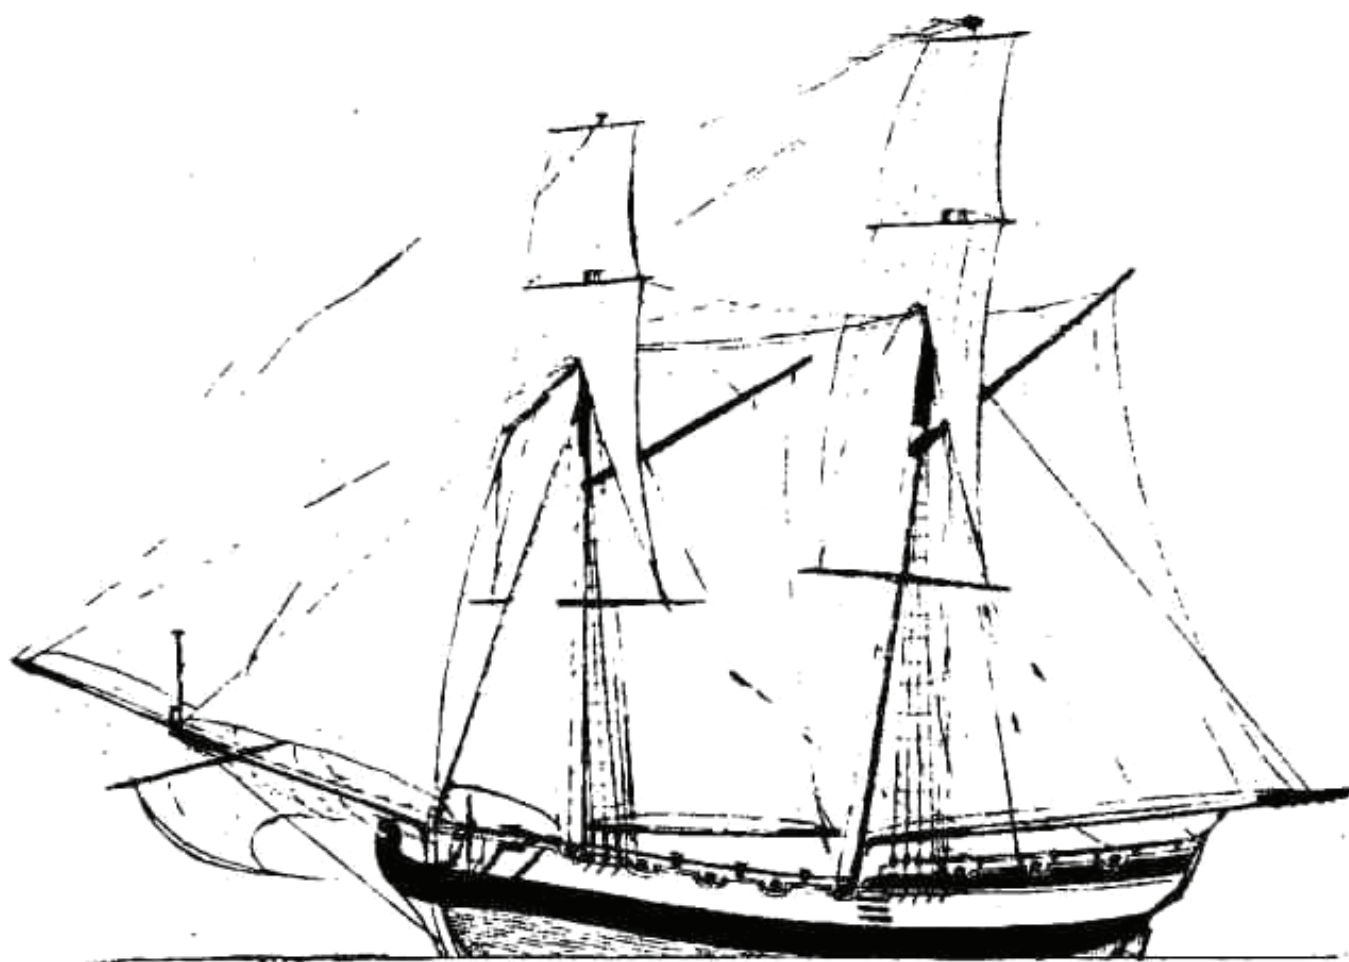
Figure 16. Vessel similar to the Otter Creek Wreck.
(MacGregor 1988:102)

Beneath the mud of Otter Creek lies an estimated fifteen to twenty-five percent of the hull, listing six degrees to port. The extant length measures 58 feet including the bow and stern rake (Figure 15, foldout). The maximum extant measurement of the beam is 16 feet and occurs at frame number fourteen.¹ At the beginning of the nineteenth century the average length/beam ratio of 3.2 to 1 was common in small merchant vessels.² The Otter Creek vessel would have been approximately 100 tons and had a draft of 9 feet.³ The vessel was likely single decked, possibly with a raised poop. The hold space would have been approximately 6 1/2 feet deep. The presence of two mast steps indicates that the vessel may have been rigged as a schooner or brig. A schooner rig is the most likely based upon the presence of mast hoop fragments from nearly all excavation units. The fore-and-aft rig was mostly used for merchant vessels, while square sails, such as on a brig, were more common on armed merchantman or naval vessels. Figure 16 illustrates a vessel believed to be similar to the one excavated at Otter Creek.

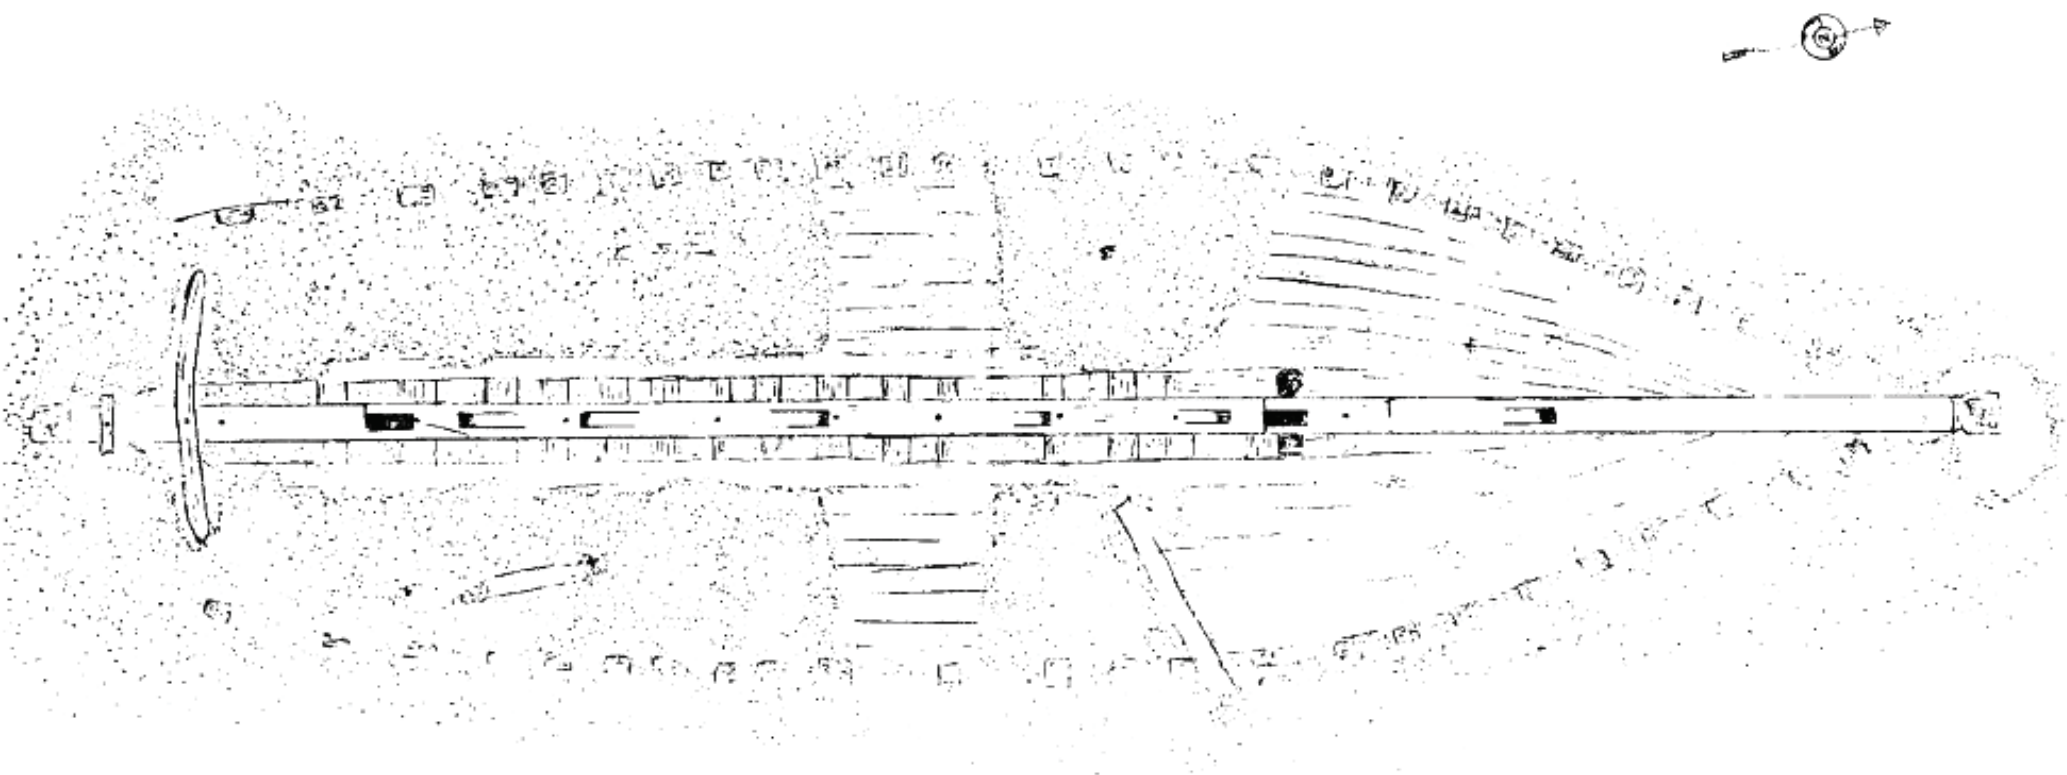
Figure 17. Perspective drawing showing excavated areas.

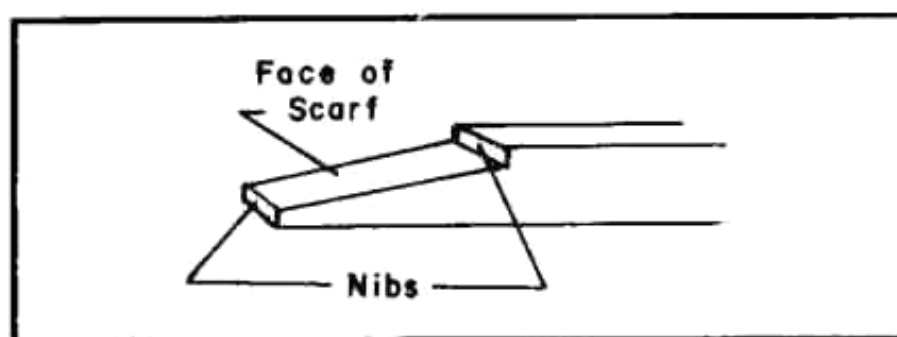
Figure 18. Drawing of keelson scarf.

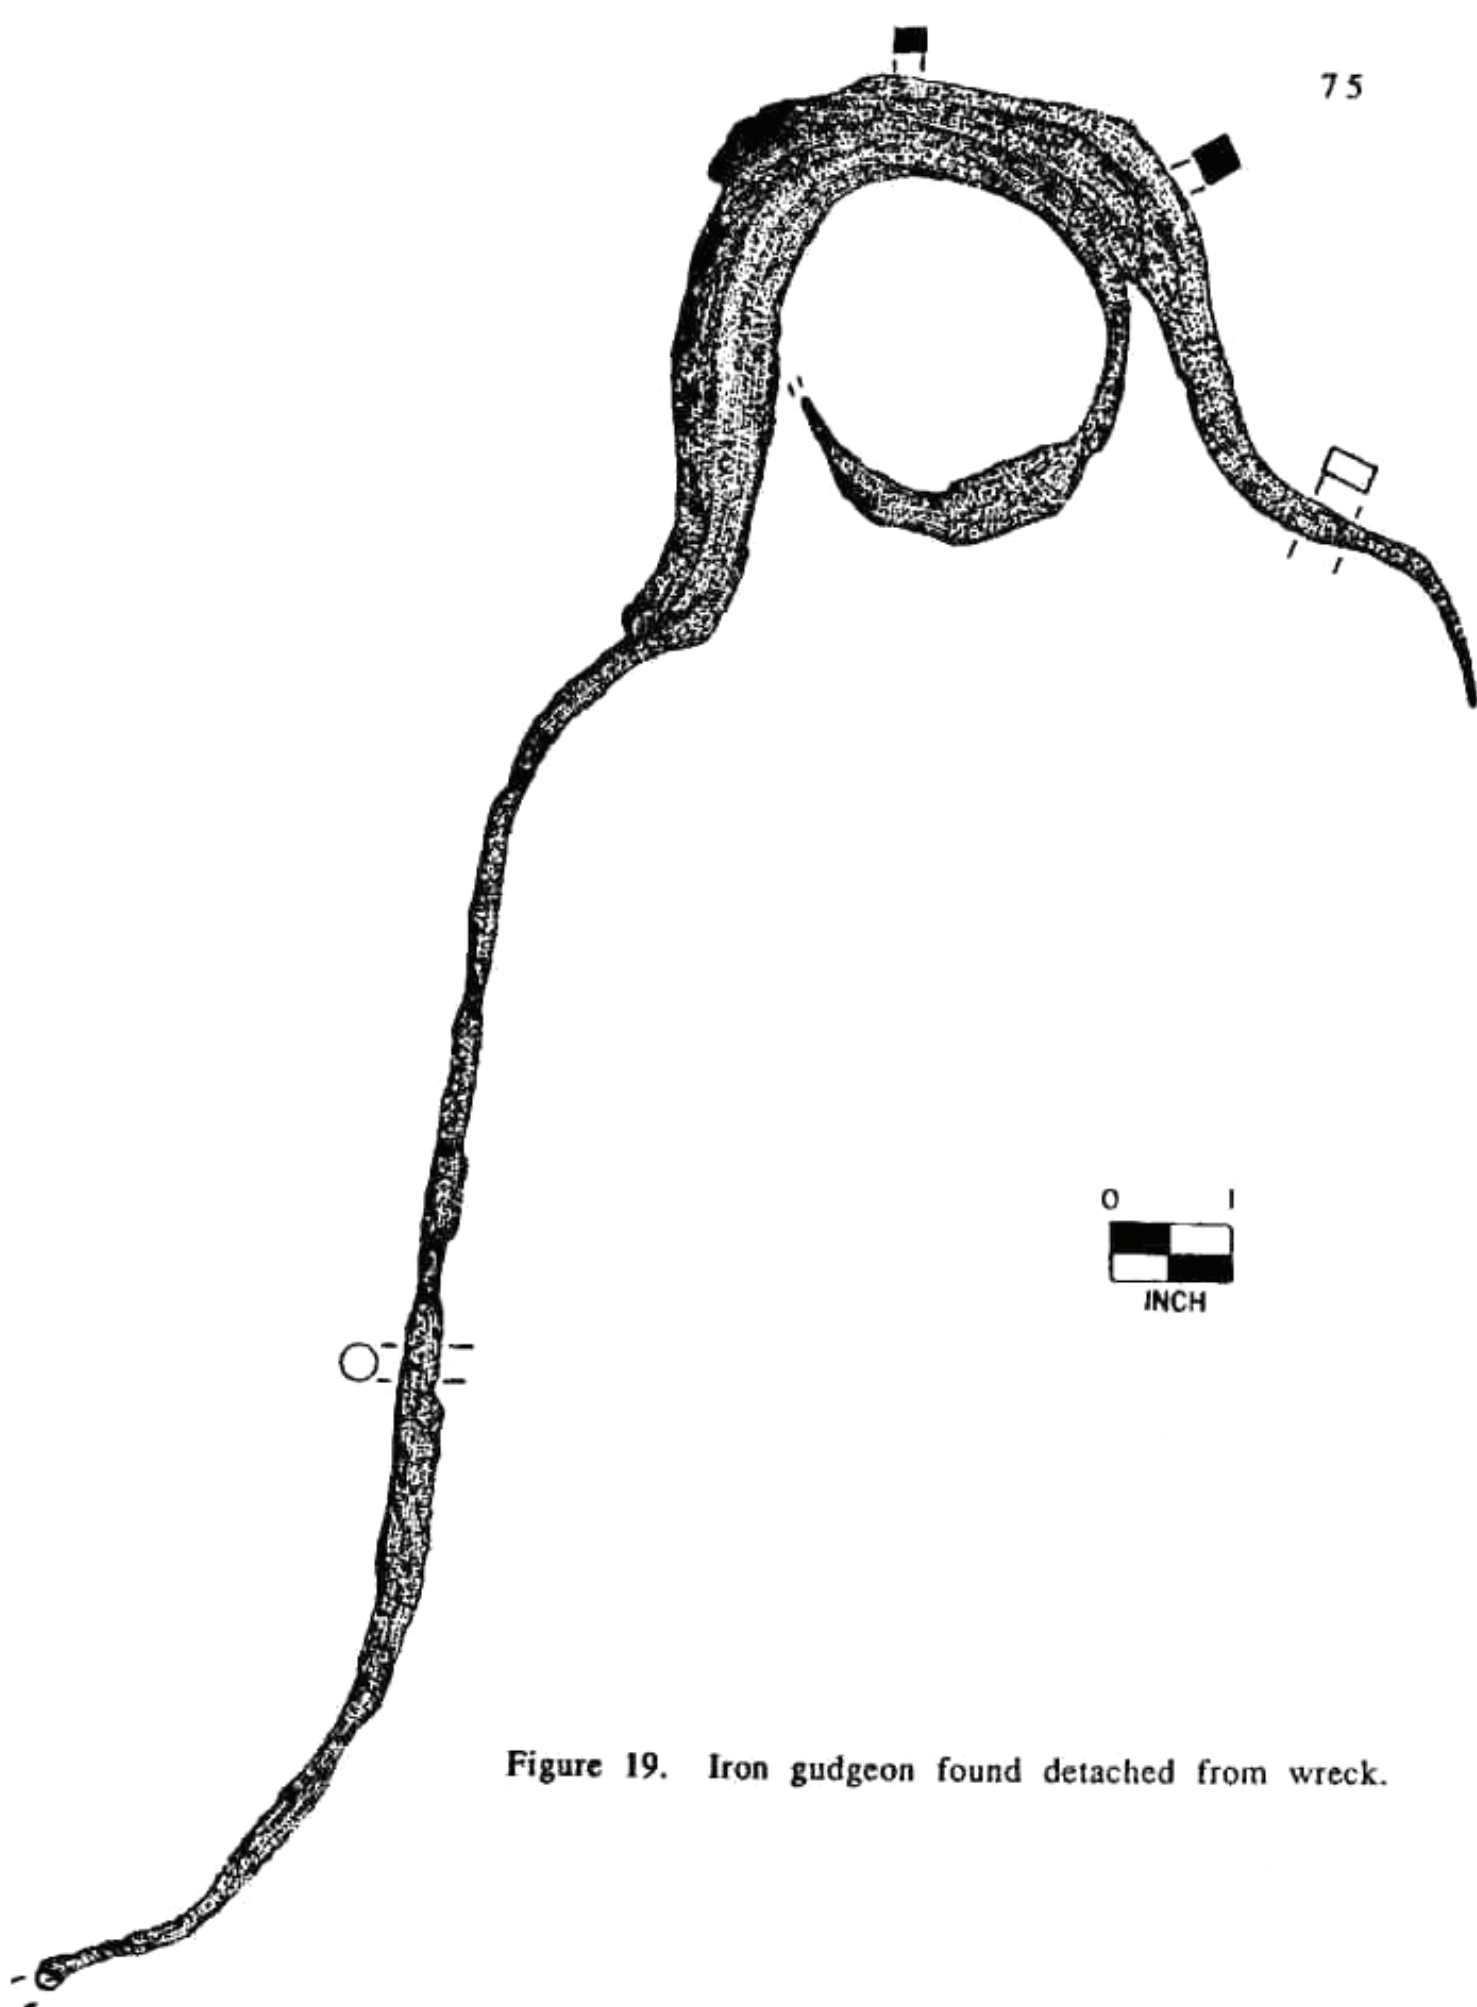
Figure 19. Iron gudgeon found detached from wreck.

Halting excavation in and around the deteriorated bow, the forward dredge was shifted to begin digging outside the vessel near the sternpost. The sternpost excavation hole did not encounter the rudder. One gudgeon strap had been recovered from the bottom sediment, while a lower deteriorated gudgeon was found attached to the lower sternpost. The stern pit continued until it reached the keel; then both the sternpost and the exposed keel were mapped. Excavators using the other dredge began widening the keelson trench within the narrow stern.

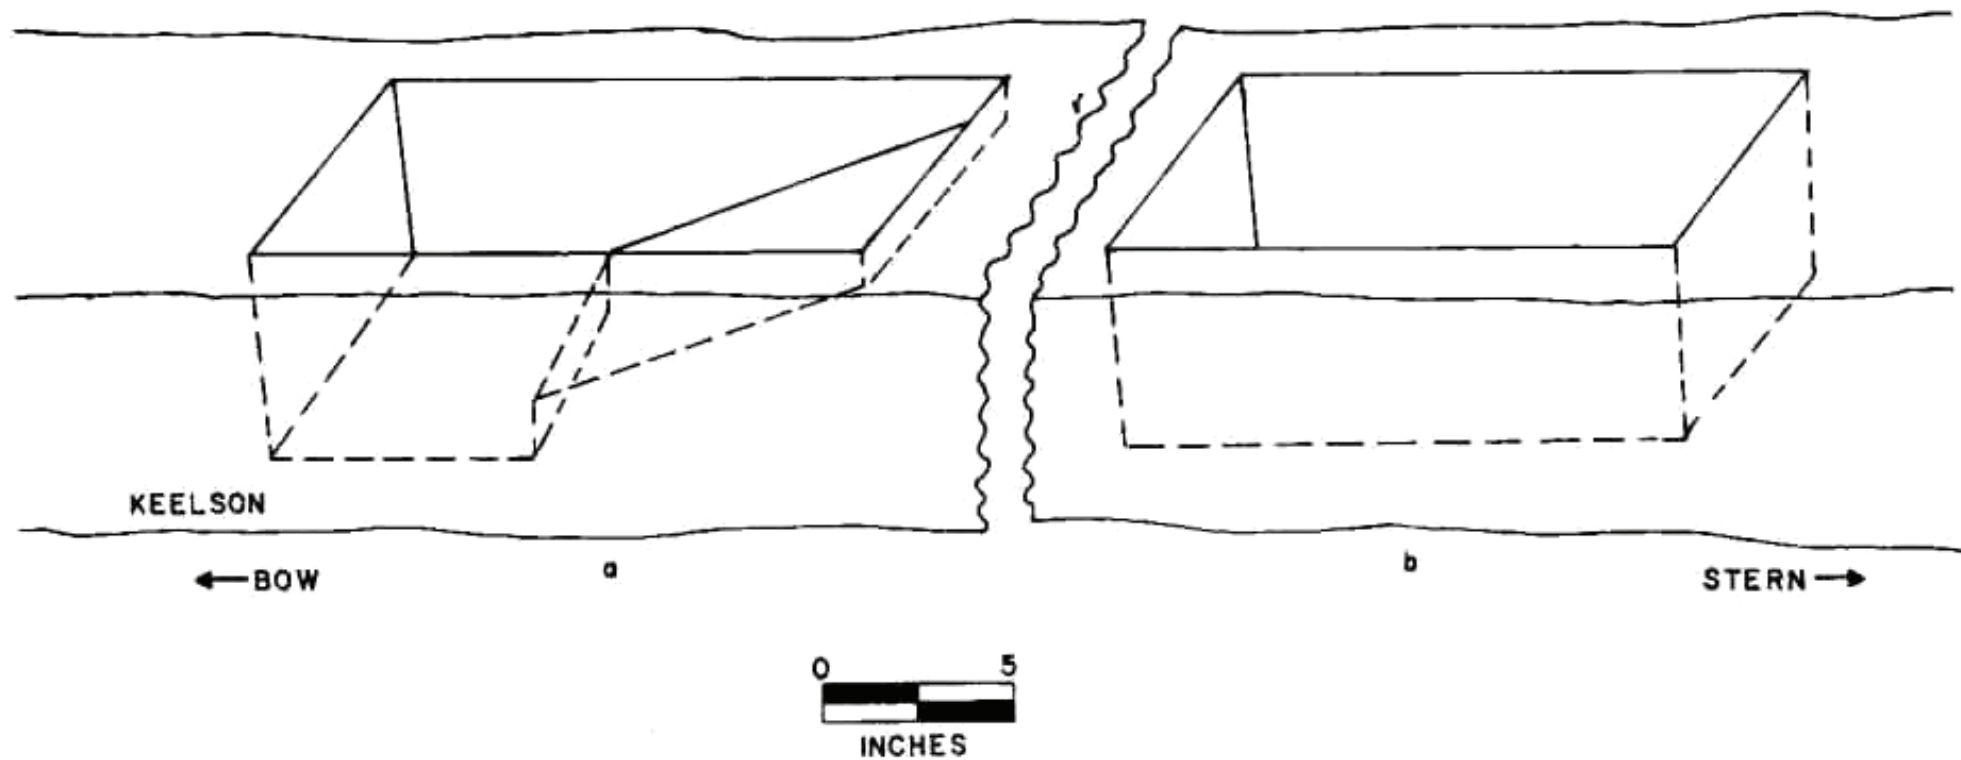
Figure 20. Drawing of (a) Forward and (b) Aft mast steps.

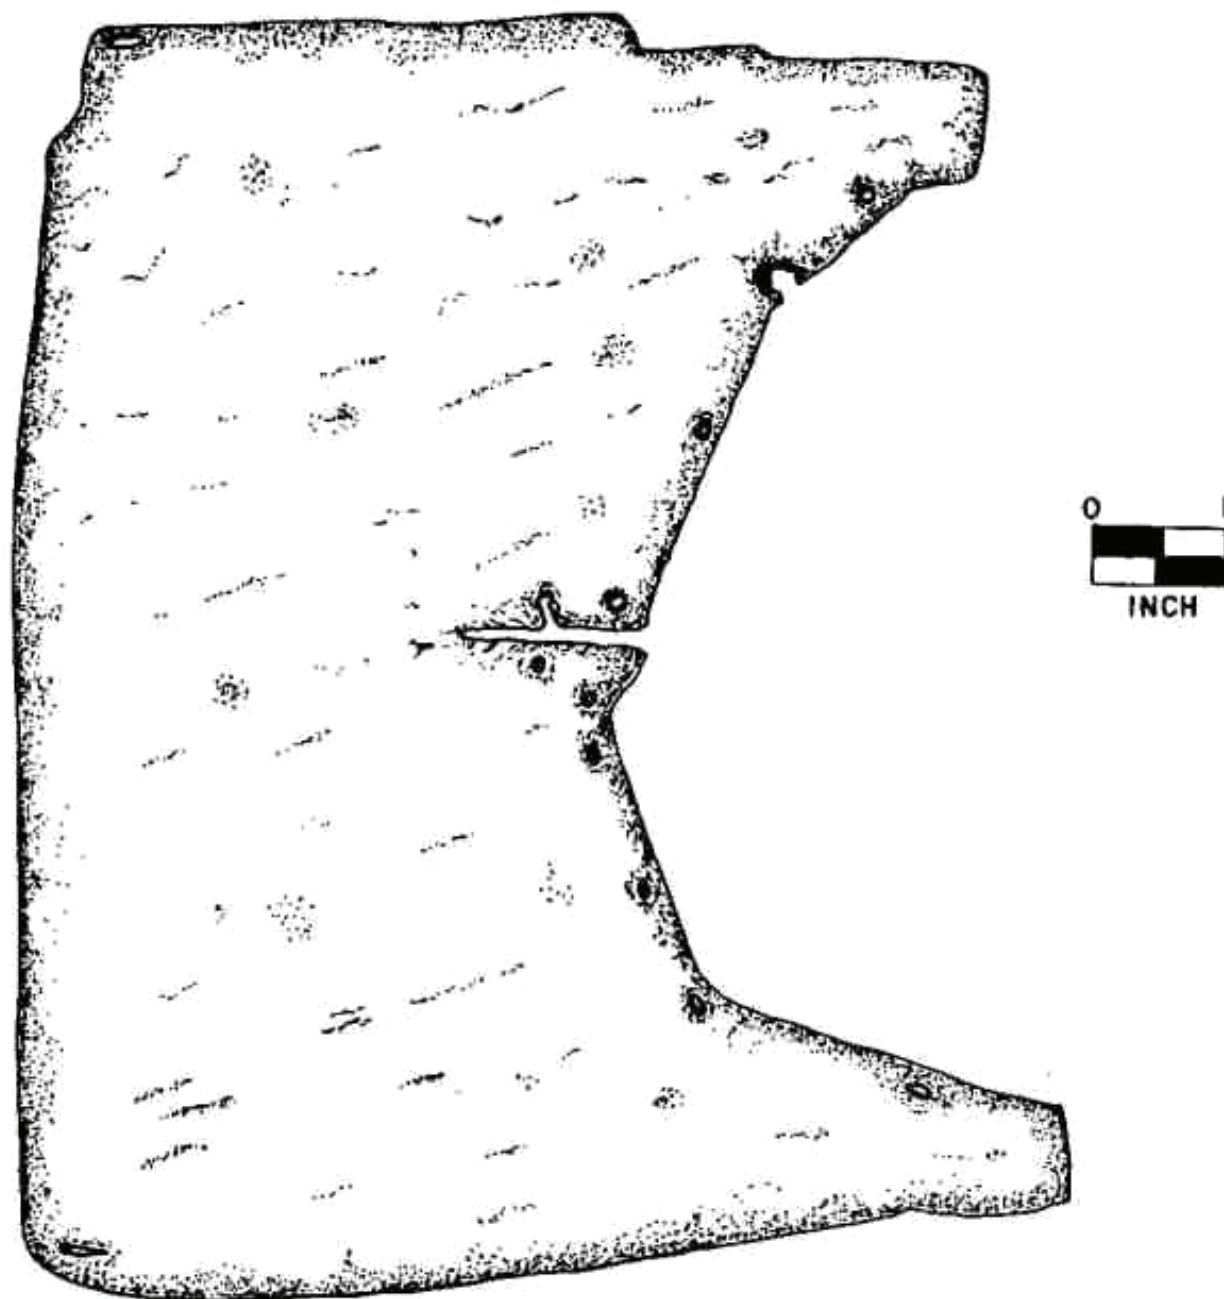
Figure 21. Leather boot from the bilge pump.

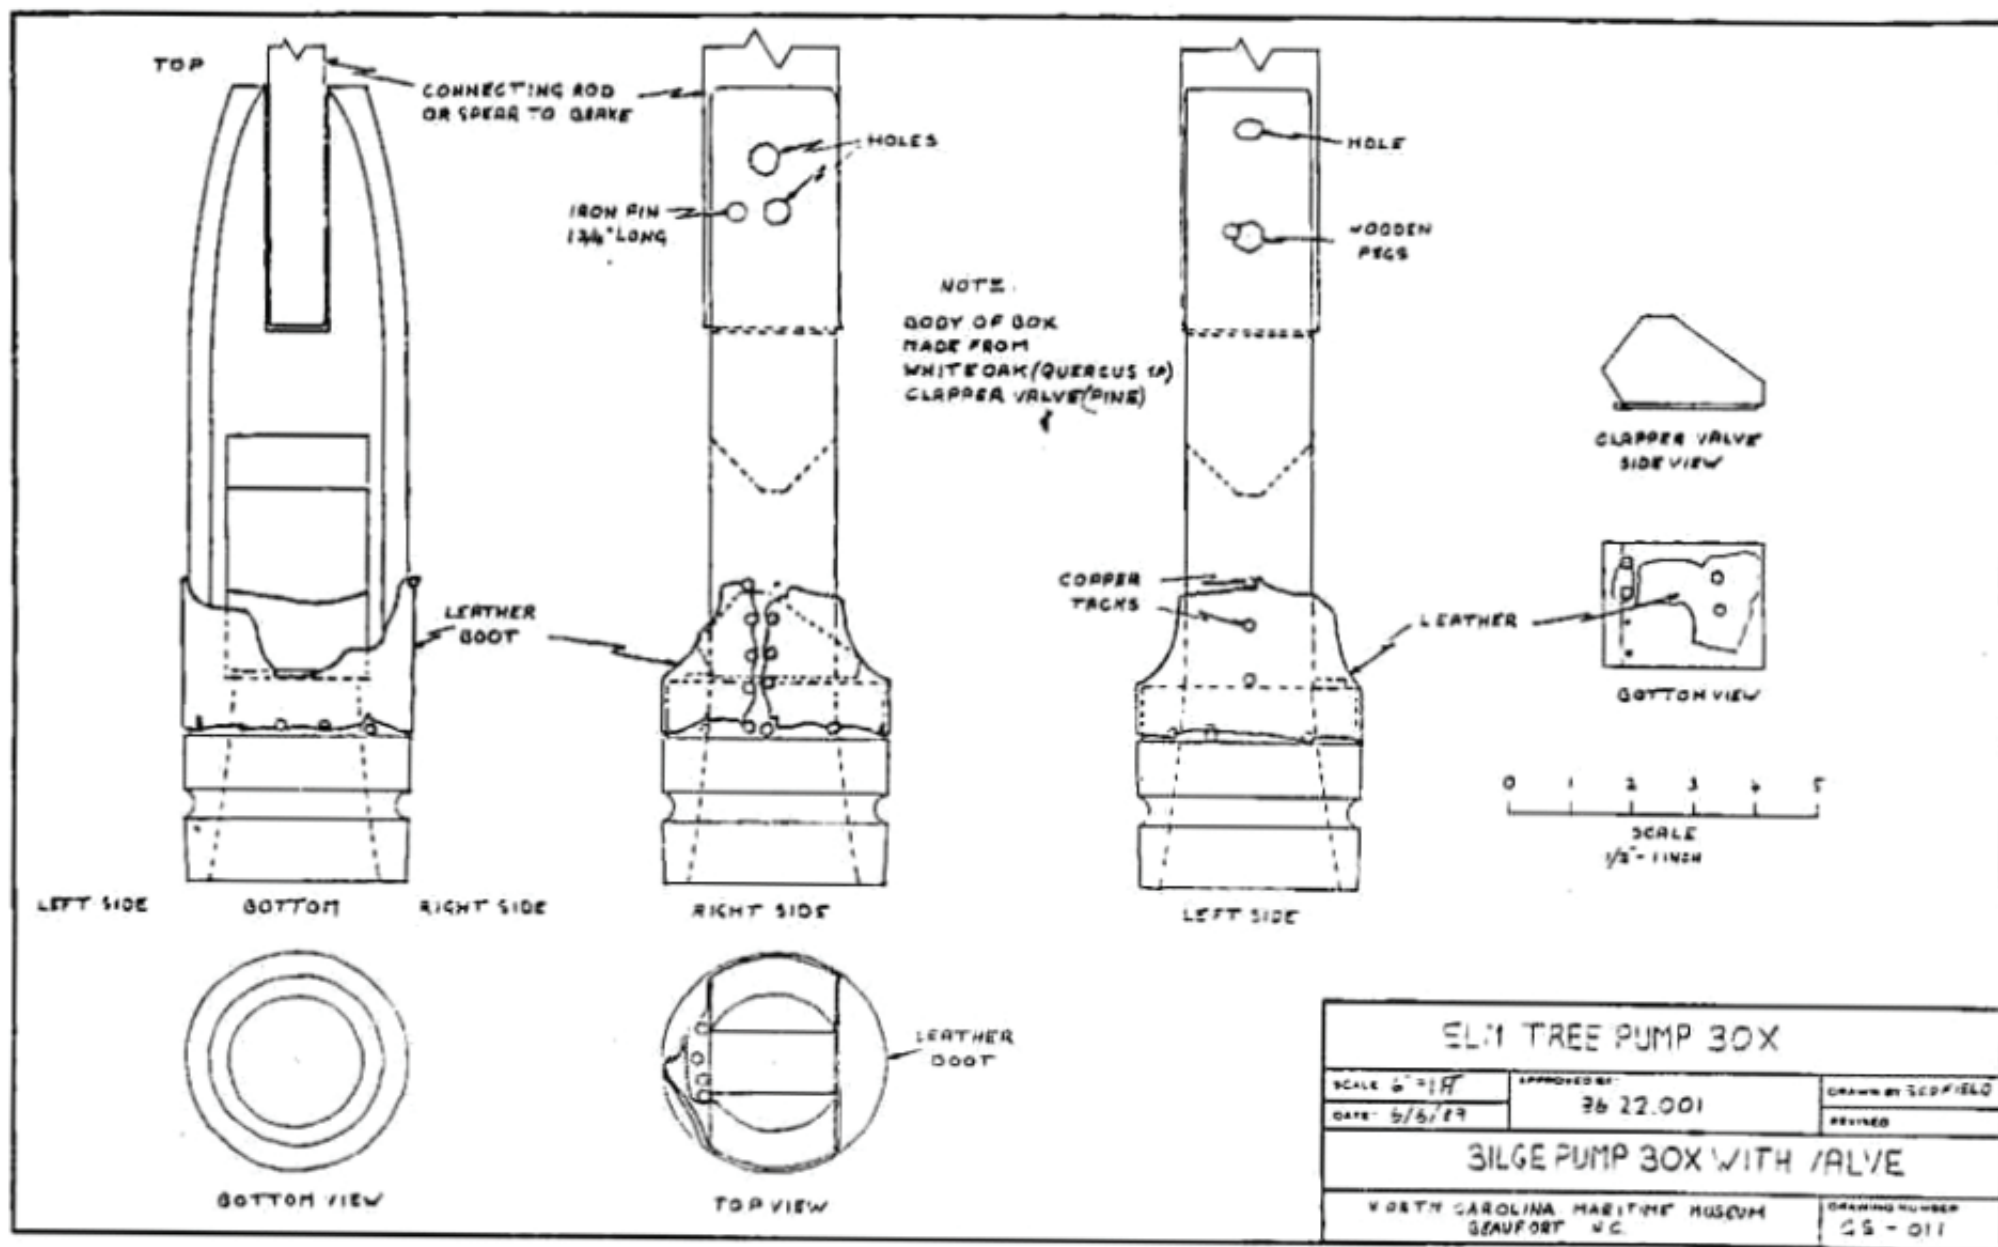
Figure 22. Elm Tree pump box.

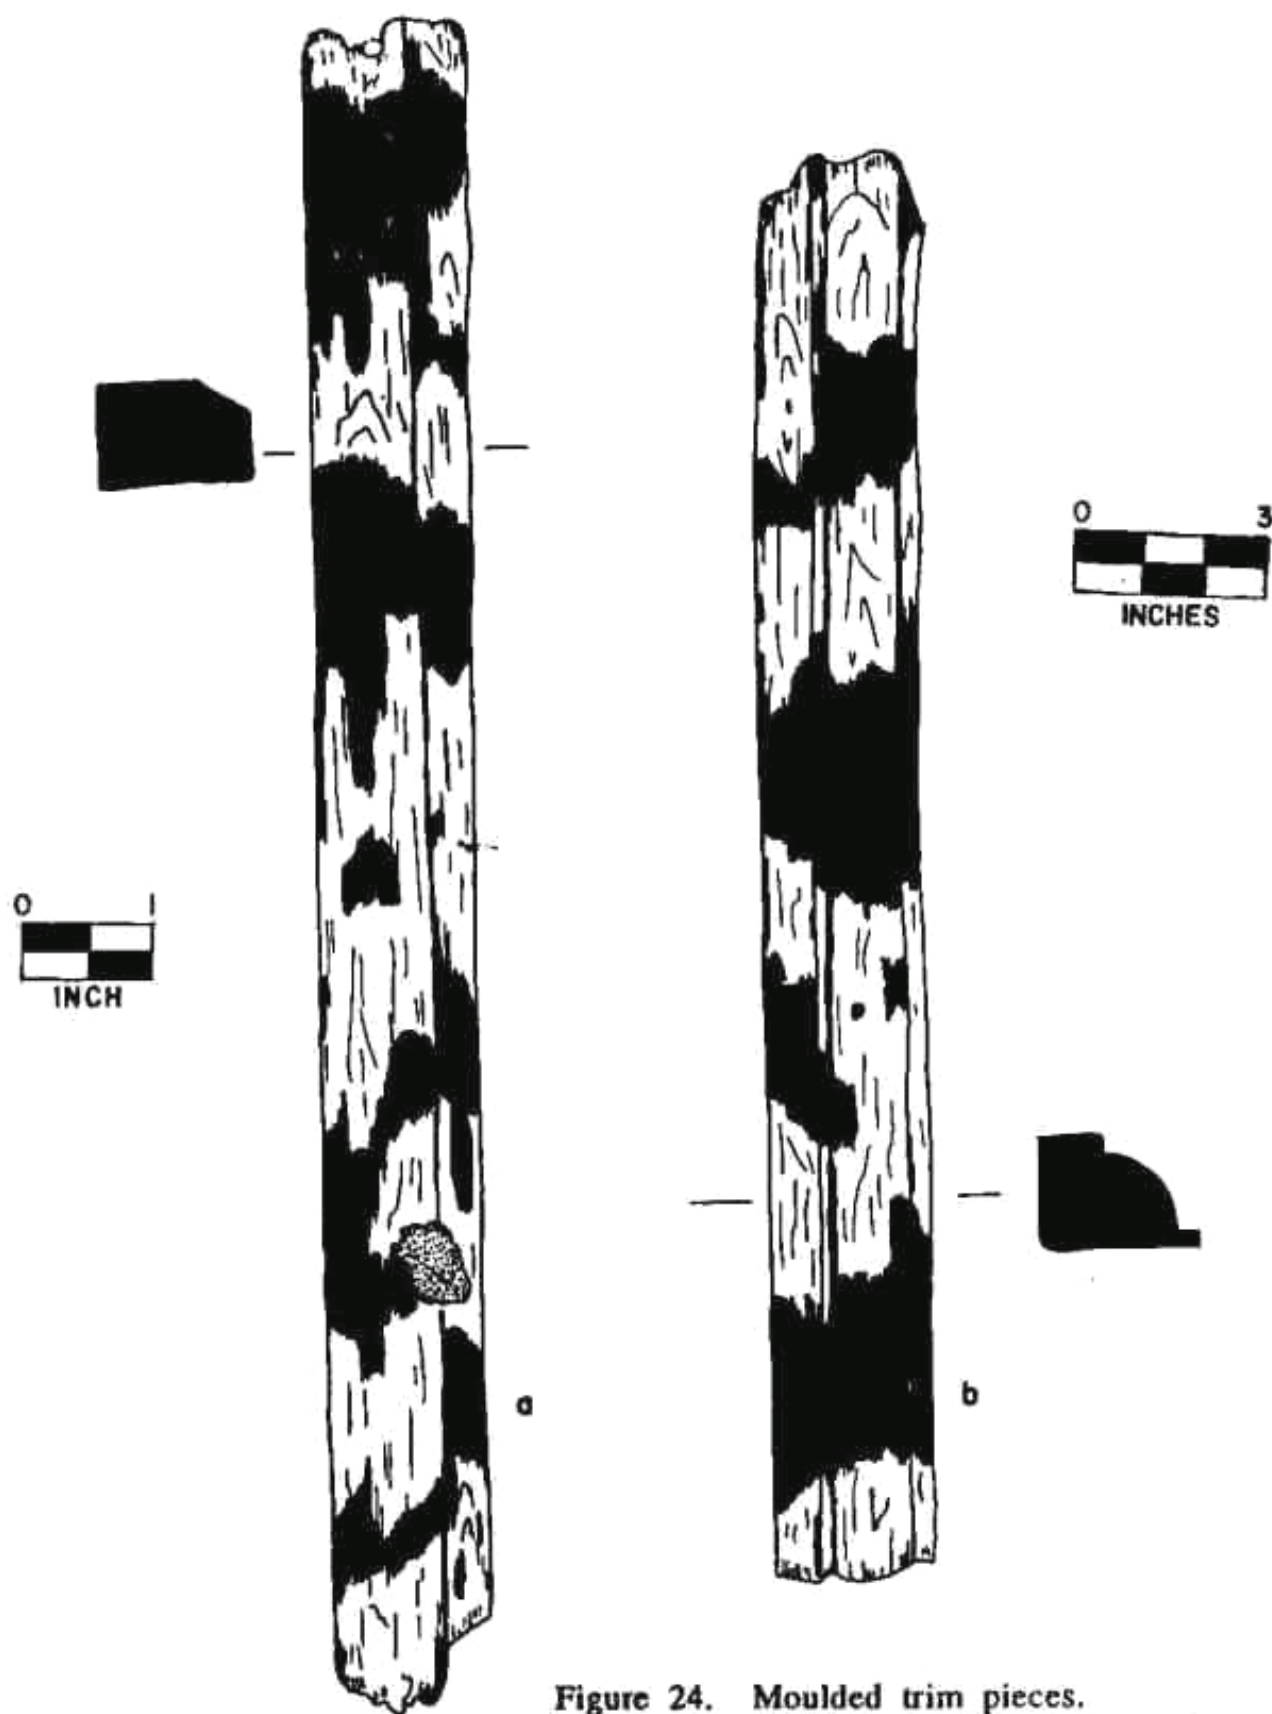
Figure 24. Moulded trim pieces.

Two molded trim pieces, similarly stained black, may also be a part of the bulkhead, or cabin design. The fragment shown in Figure 24a came from unit 5C and has one beveled edge. Two nail holes are present - one circular at the point of fracture, and another 1/8 inch square. Figure 24b is unprovenienced and shows a finished moulded edge. One small nail hole is present. The captain's quarters were sometimes built along the lines of deck beams.⁸¹ Stanchions, upright pieces of timber, would have been used to support the bulkhead.⁸²

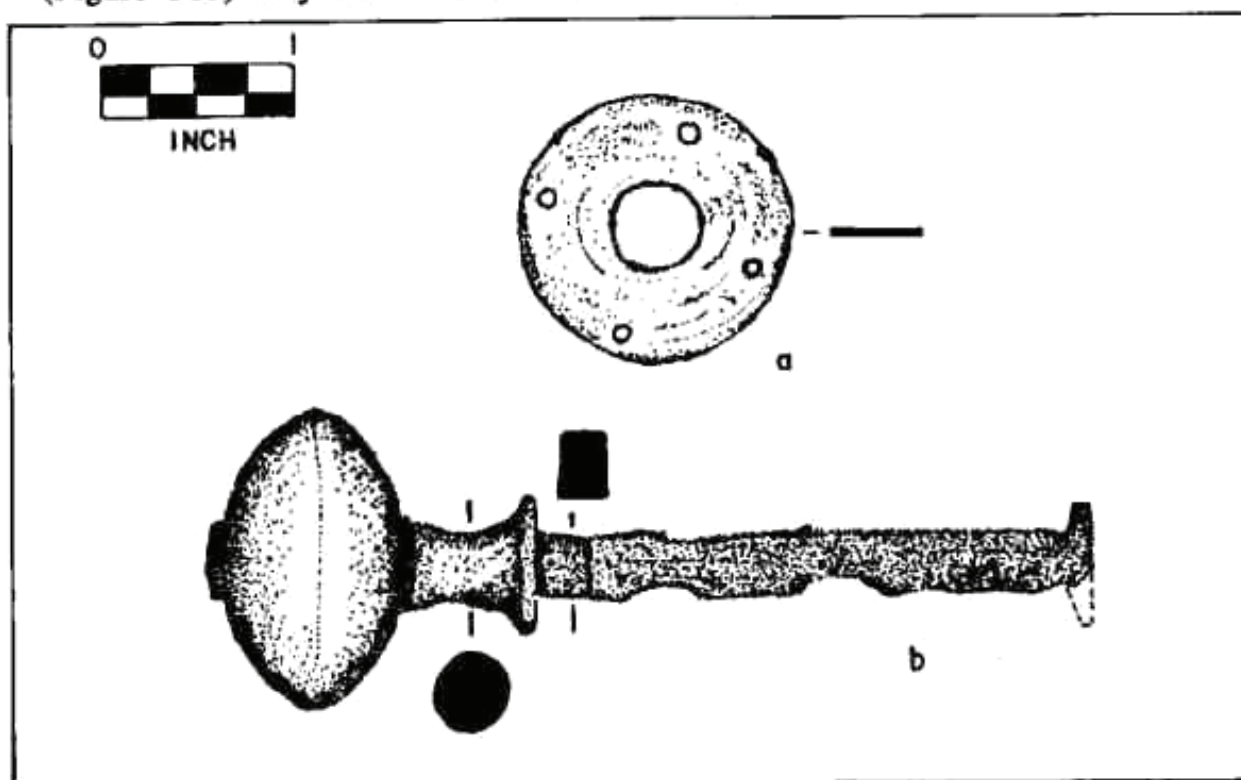
Figure 25. Door knob assembly.

There is an indication that a door might have led into a cabin. A door knob assembly was recovered from unit 4D. (Figure 25). The assembly comprised an oval knob made of brass, 1 1/2 inches wide, an attachment plate also of brass and of the same width, and a square shank made of iron. The length of the shank indicates that the door would have been at least 3 inches thick. The brass plate was attached to the door with four nails. The recovery of a hinge (Figure 50b) may also indicate the likelihood of a cabin door.

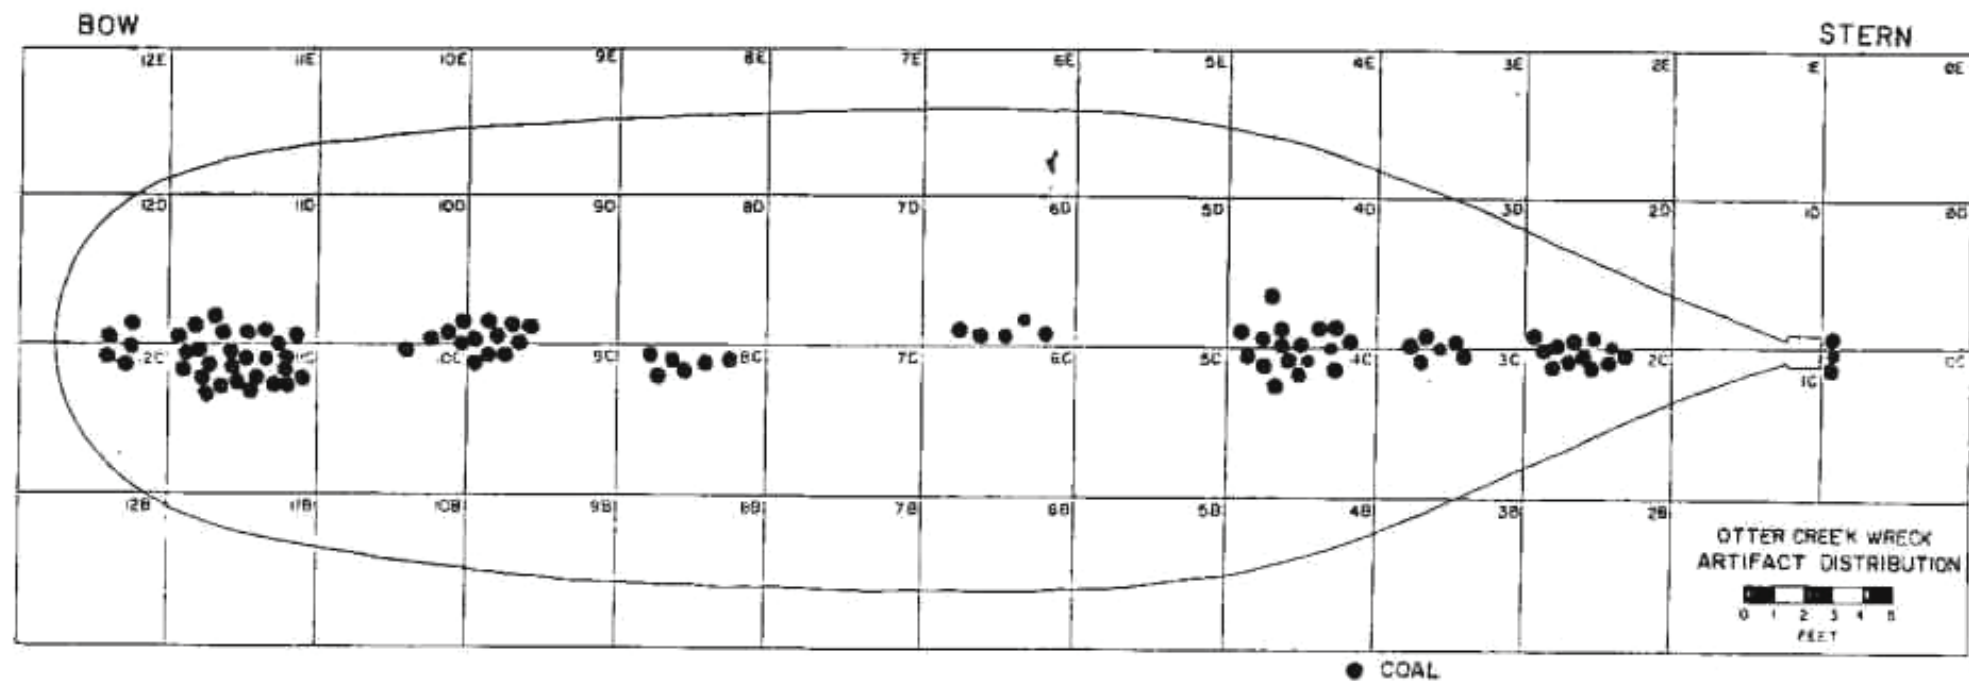
Figure 29. Distribution map of coal.

Nine brick fragments and 180 pieces of coal, 5.59 pounds (2.54 kg) scattered in the ends of the vessel suggest the presence of two stoves on board (Figure 29). Merchant wooden sailing ships generally carried a brick cooking stove in the forward part of the ship aft of the fore mast. Within the captain's cabin, located in the stern, a second, smaller stove was not uncommon. It is unlikely that the coal represented cargo.

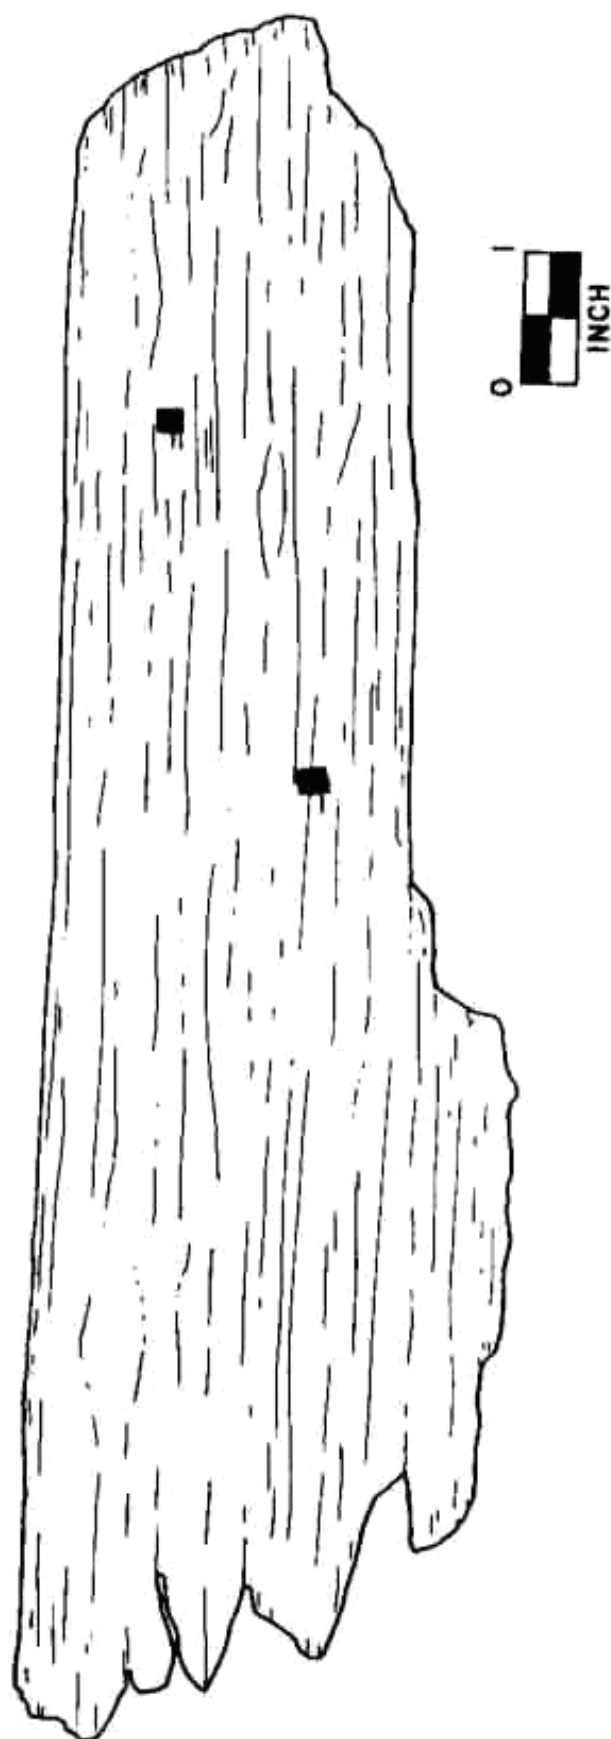
Figure 30. Sheathing sample.

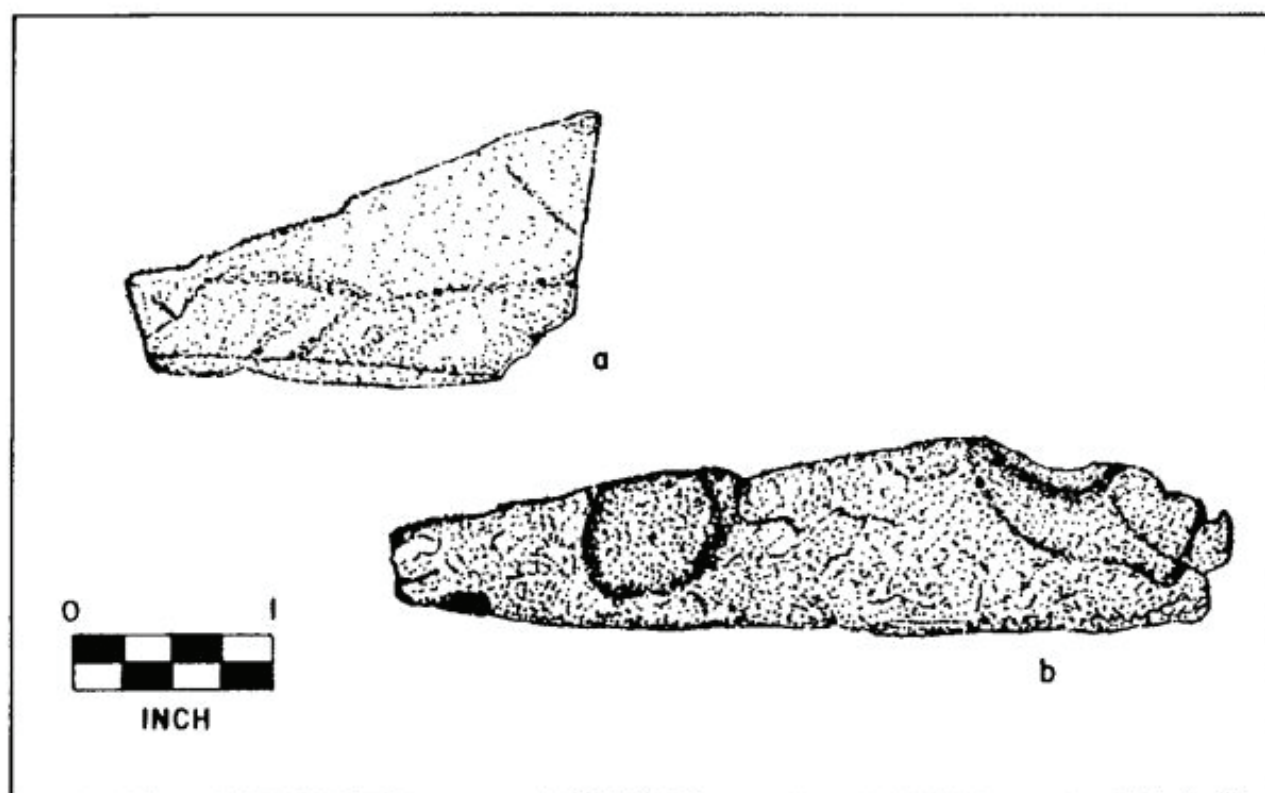
Figure 31. Lead patching.

Two pieces of what may be lead patching, or tingles, were recovered from the wreck (Figure 31). One thin triangular-shaped piece (Figure 31a) came from unit 8D. A second piece $1/16$ inch thick was found in the stern area (Figure 31b). Neither piece shows attachment holes. Their use is speculative, but they may be fragments used for hull patching or draft numbers. Two small non-sheathing pieces of lead were also recovered from unit 6C. Their use is unknown.
