Historical and Archaeological Investigations of a Sunken Federal Period Vessel near Oriental, North Carolina

Underwater Archaeology Branch
Division of Archives and History
North Carolina Department of Cultural Resources
Kure Beach, North Carolina
1992

A Thesis
Presented to the
Faculty of the Department of History
East Carolina University

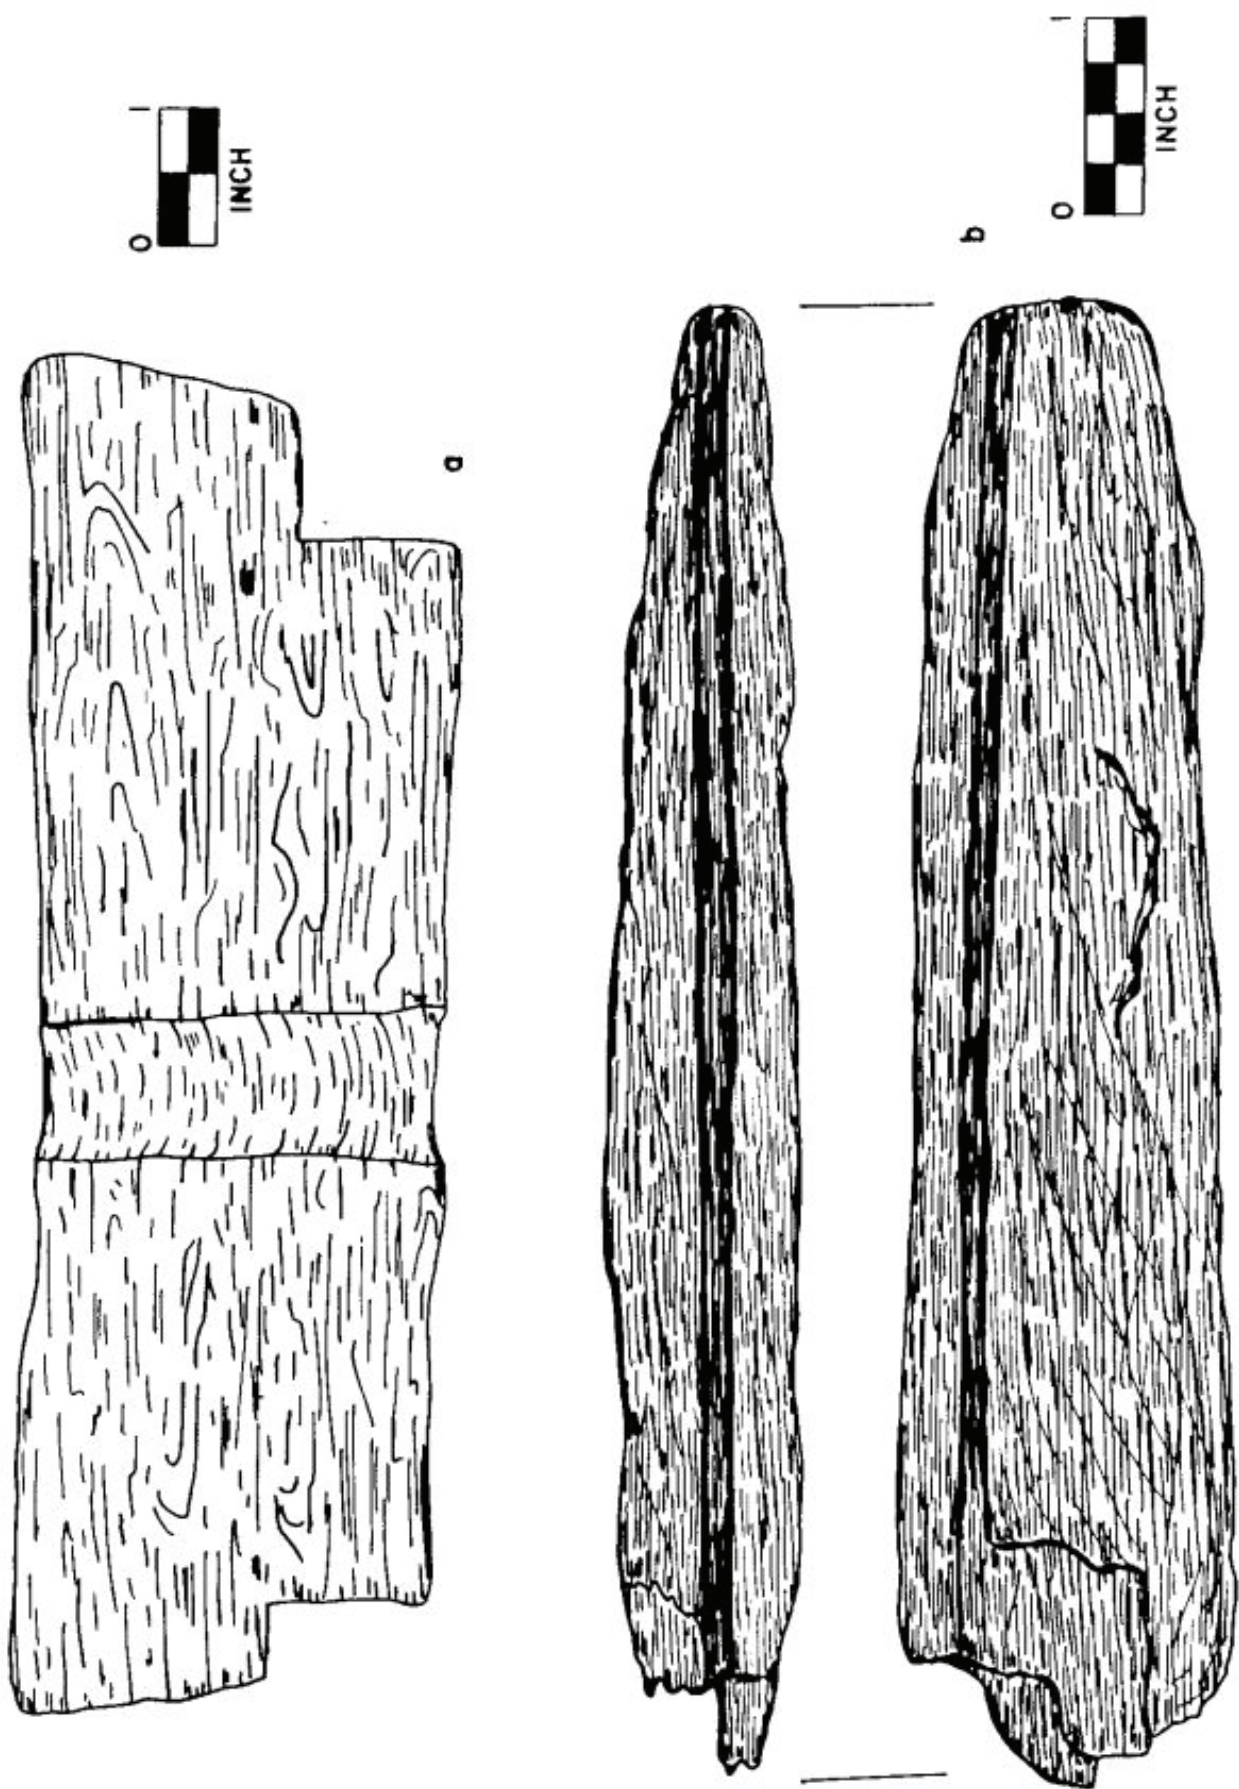
Figure 35. (a) Chock and (b) grooved piece.

The weathered specimen shown in Figure 35b was found in unit 7C. It has a 3/16 inch wide groove around one edge. The specimens in Figure 36 both from the stern area were likely used as braces. Specimen (a) is notched and attached with a single nail fastener. Specimen (b) displays two iron nail fastener holes.

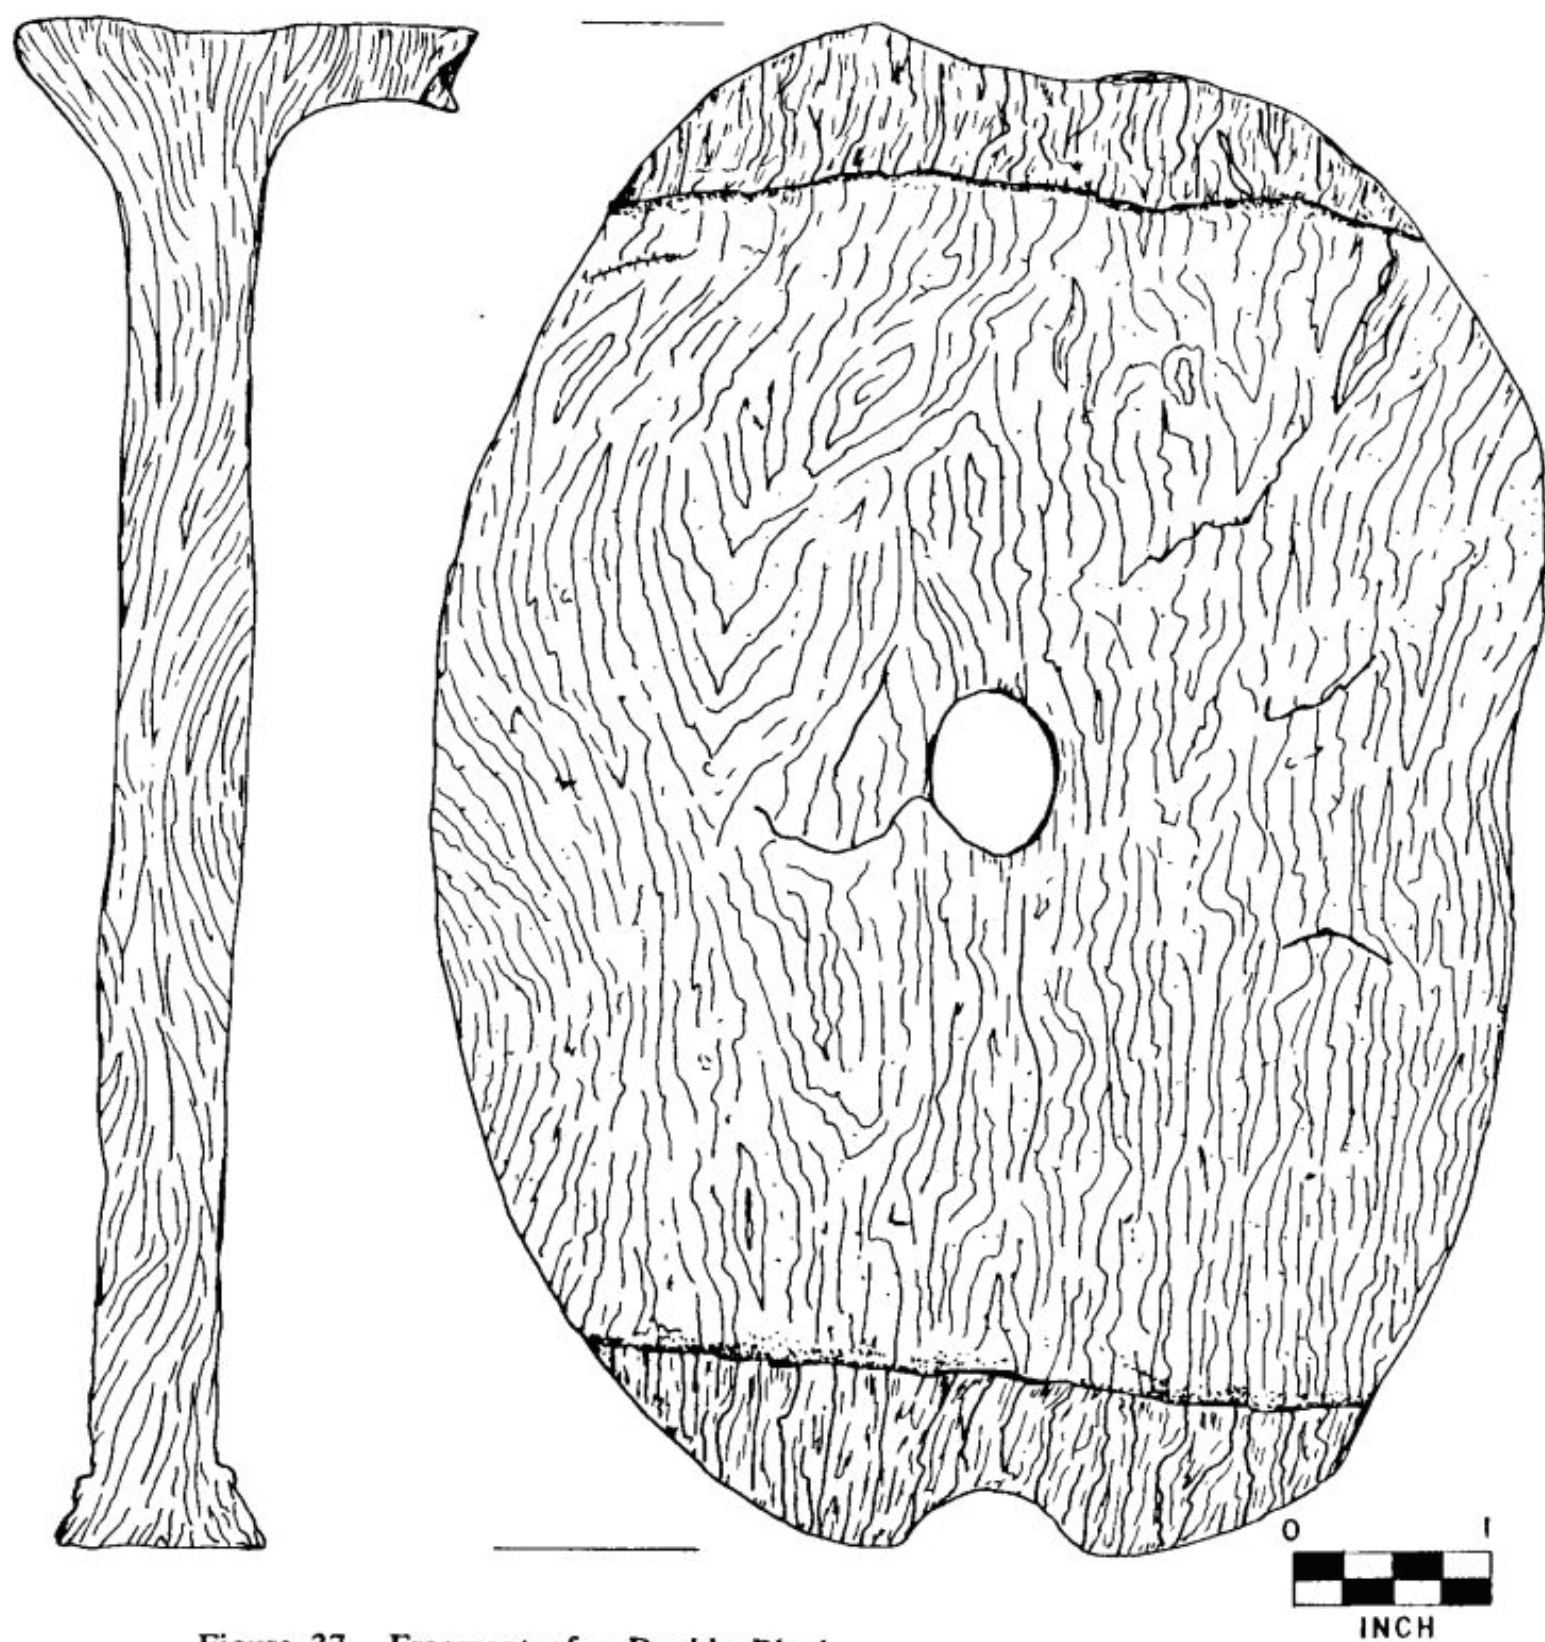
Figure 37. Fragment of a Double Block.

The double block fragment, 8 inches in length and 6 1/2 inches wide, was recovered from unit 4D. Timbers common in the construction of blocks are elm, ash, or beech, but this specimen was not submitted for testing. The sheave fragment came from the sternpost excavation, unit 0C, and shows parallel cut marks. It has a thickness of 3/4 inch and is likely shaped from *lignum vitae*. The thickness of a sheave was generally 1/10 greater than the diameter of the rope used with it.¹¹¹ The seven sheave pins were recovered from units 0C, 2D, 4C-D, and unprovenienced. Indention points on the ends of some of the sheave pins show evidence of having been turned on a lathe. The bull's eyes came from units 2C-D and 4C-D. The only piece of cordage preservable is a 2 1/4 inch long piece of 1/2 inch S-twist, two-cord specimen found in Unit 4C-D. A second small section of cordage was noted as having come from Unit 4C-D.

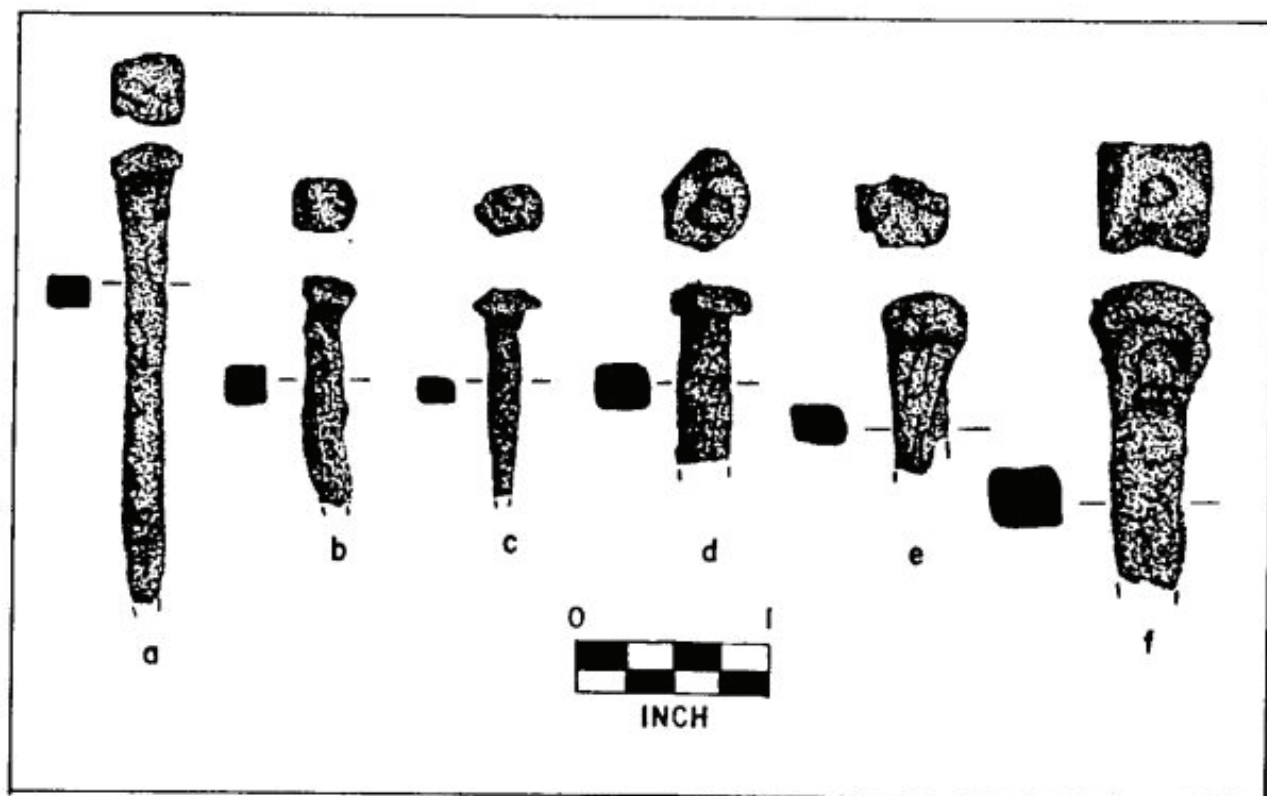
Figure 49. Nails and spike.

Square-headed small-shanked nails ranged in extant lengths from 1 inch to 2 3/8 inches (Figure 49a,e). Rose-headed nails also preserved on this wreck ranged in remaining lengths from 7/8 inch to 1 1/4 inches (Figure 49b,c,d). Wrought-iron rose-headed nails with hammered facets on the head date to about the period 1790-1820. Wrought nails, however, continued to be used for several decades following the introduction of the cheaper cut nails.¹²⁸ Following the Revolutionary War, Britain continued to dominate in the manufacture of nails. Most nails used in this country from the late eighteenth century until the early nineteenth century were imported from England.¹²⁹ It is also likely that the quantity of nails used in the construction of the Otter Creek wreck could have been produced locally. William and John Gray Blount had established a large nailery in 1788 in Washington, North Carolina.¹³⁰ An analysis of the percentage of metals in nails can be used to date the manufacture of the fastener within fifty years.¹³¹ None of the Otter Creek fasteners were submitted for an analysis of their metallic content.

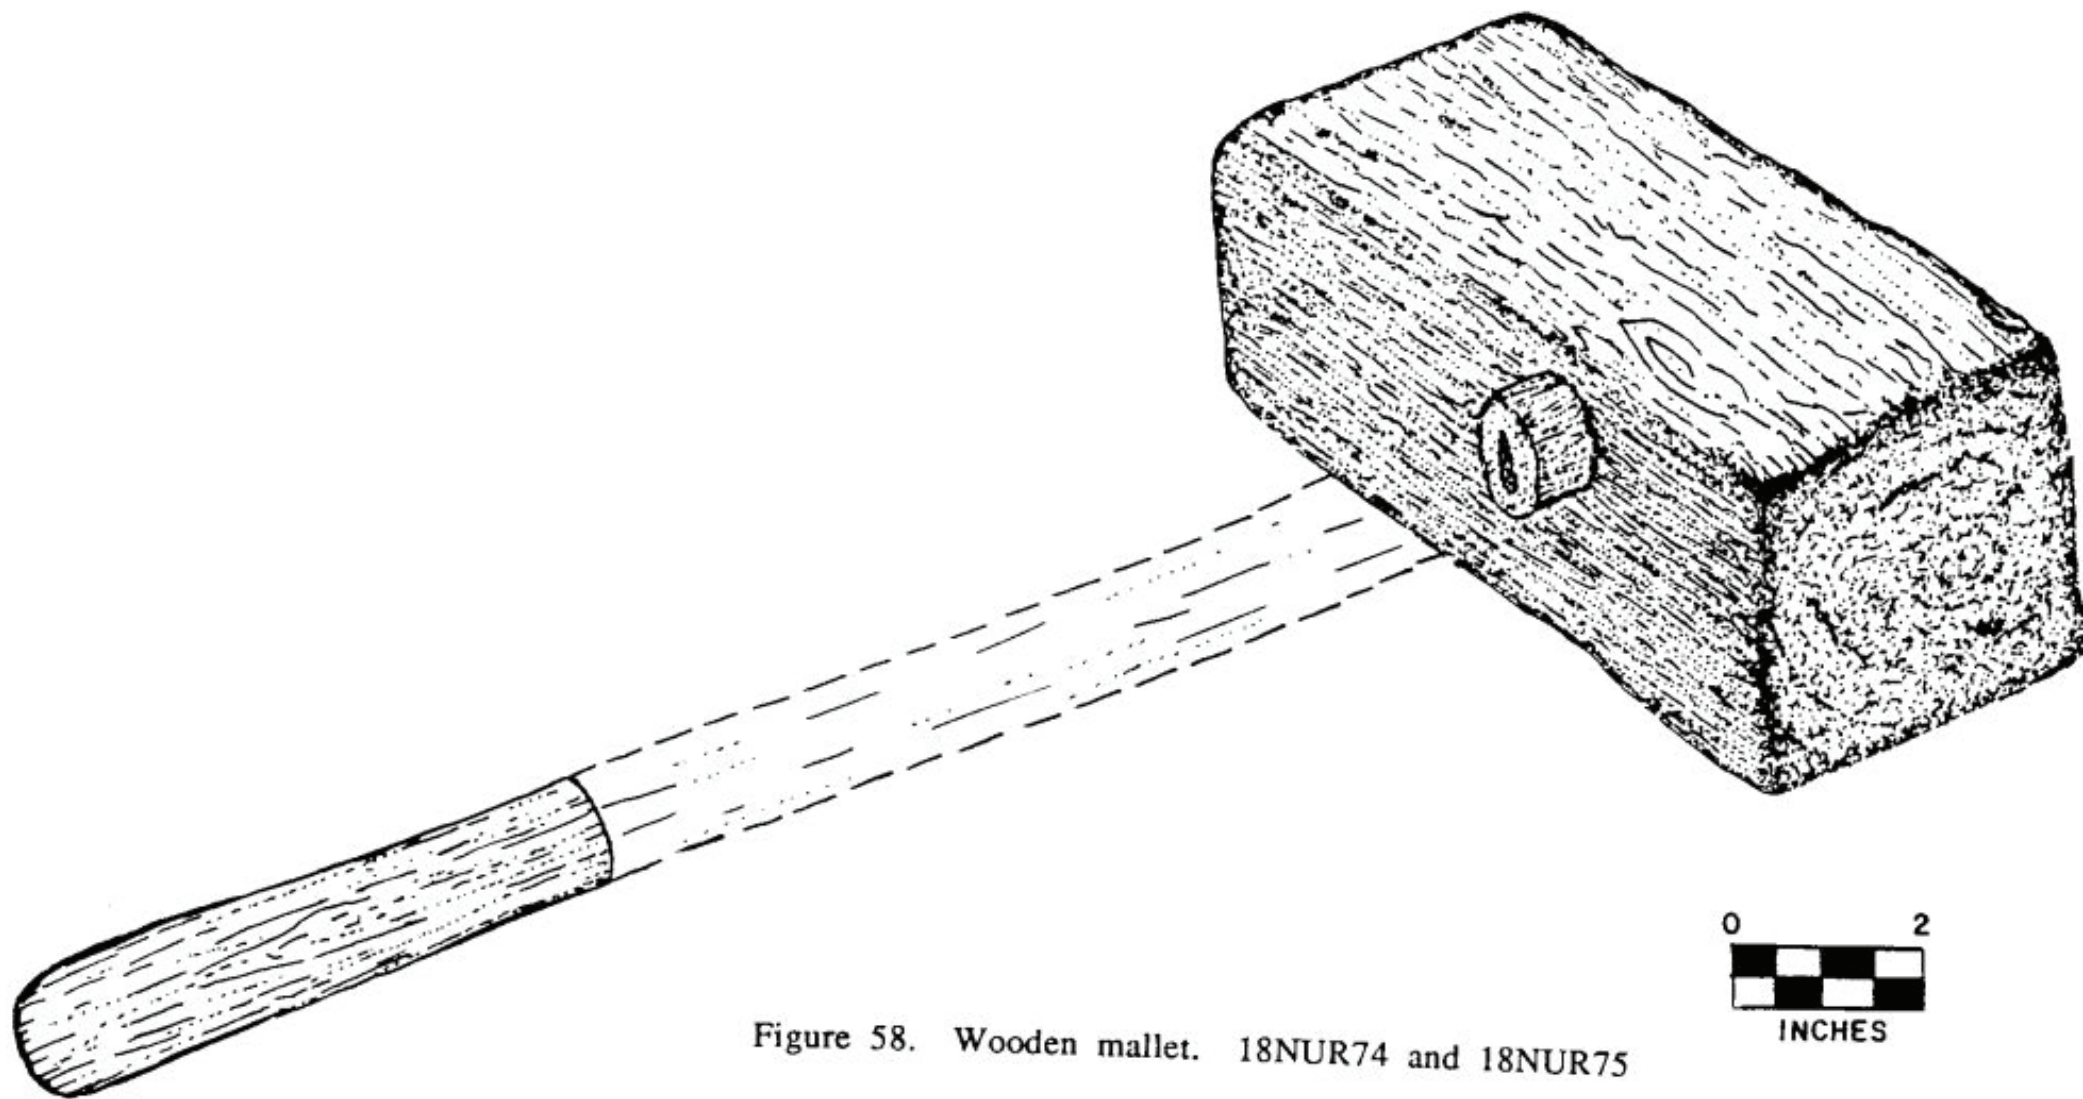
Figure 58. Wooden mallet. 18NUR74 and 18NUR75

SPECIMENS 18NUR74 and 18NUR75 have been identified as a mallet head and handle fragment respectively (Figure 58). The two pieces came from unit 6C. The rectangular wooden mallet head measures 7 inches by 3 inches by 3 inches. Wear from use shows on

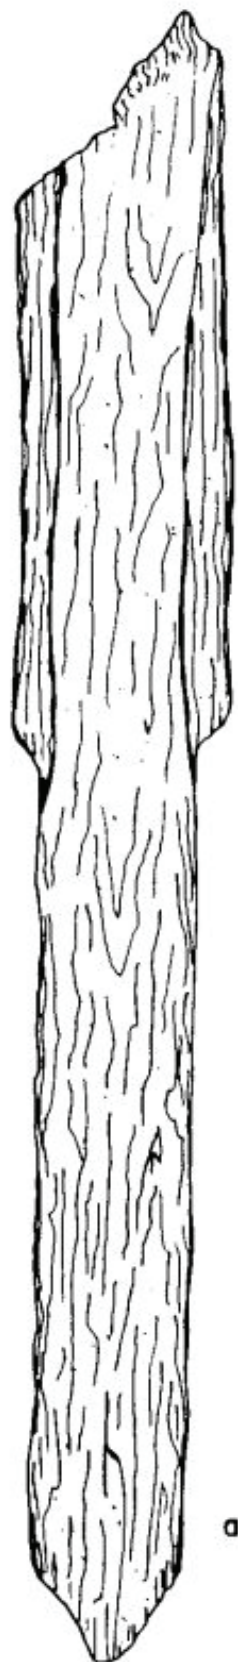
During the eighteenth century two types of wooden hoops were used in the construction of casks: an overlap notched hoop, and hoops fastened at the ends by a lashed split reed. Specimen 18NUR146 illustrated in Figure 65 may be an example of an overlapping lashed-type hoop. The notched example appears to be the less used of the two methods during the eighteenth century⁴⁴. Of the willow and chestnut hoops recovered from the Yorktown wreck scuttled in 1781, however, this was the type found most often. The majority of the hoops were wooden on the Yorktown wreck, although at least two cask assemblies were found to be bound with iron hoops.⁴⁵ Wooden hoops found on the Yorktown wreck also present the first evidence of nailed hoops, with one cask assembly having 51 nails along the top. Flagging, battens, and hoop liners were also documented on this wreck.⁴⁶

Figure 65. Possible overlapping lashed hoop end. 18NUR146

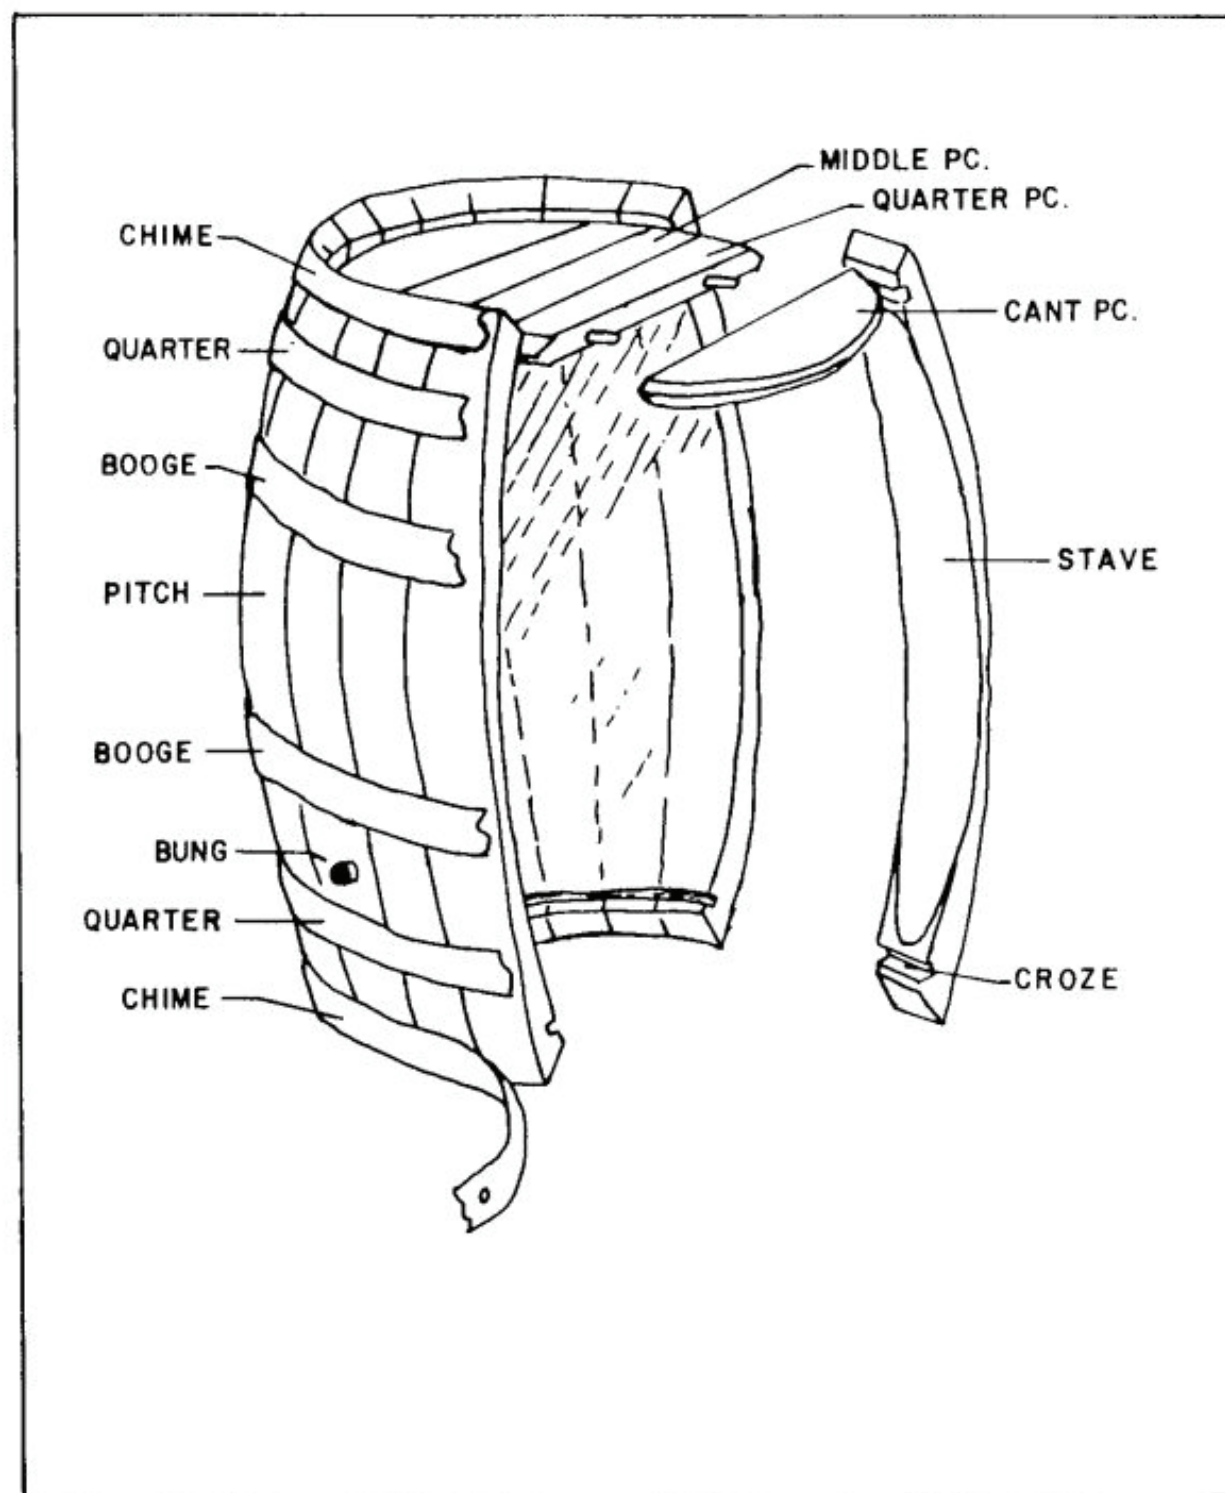
Figure 67. Cask components (after Shackleford, 1988).
