CSS Raleigh

The History and Archaeology of a Civil War Ironclad
in the Cape Fear River

CSS RALEIGH
THE HISTORY AND ARCHAEOLOGY OF A CIVIL WAR IRONCLAD
IN THE CAPE FEAR RIVER

A Thesis
Presented to
the Faculty of the Department of History
East Carolina University

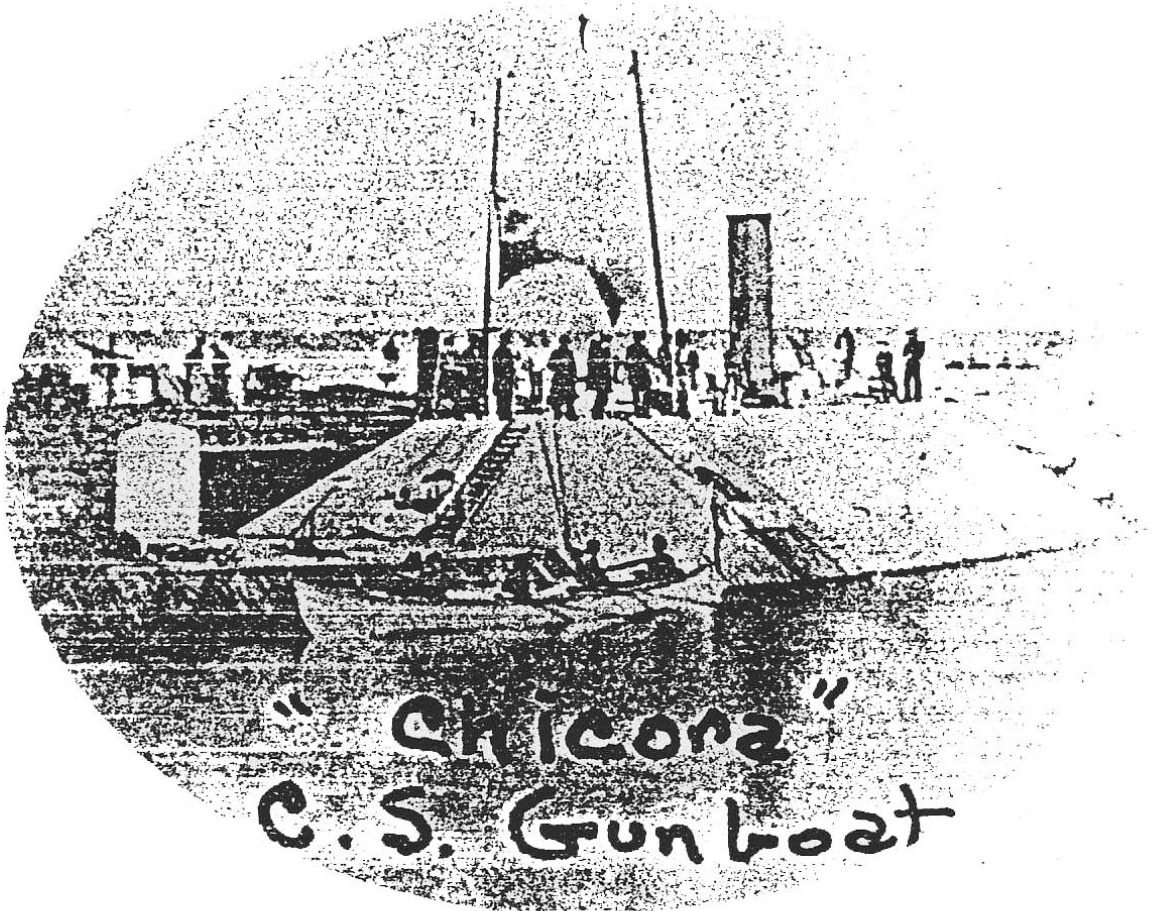
Figure 5: CSS *Chicora*, daguerreotype. Stern view is barely evident by comparison with other plans. Noting "starboard" side battery is considerably forward, in background, the pilot house is also to the rear, in the foreground behind the officers standing on the spar deck. (Photo: William C. Davis, ed., *The Image of War*, Vol. II, 80: Courtesy of Old Court House Museum, Vicksburg, Mississippi)

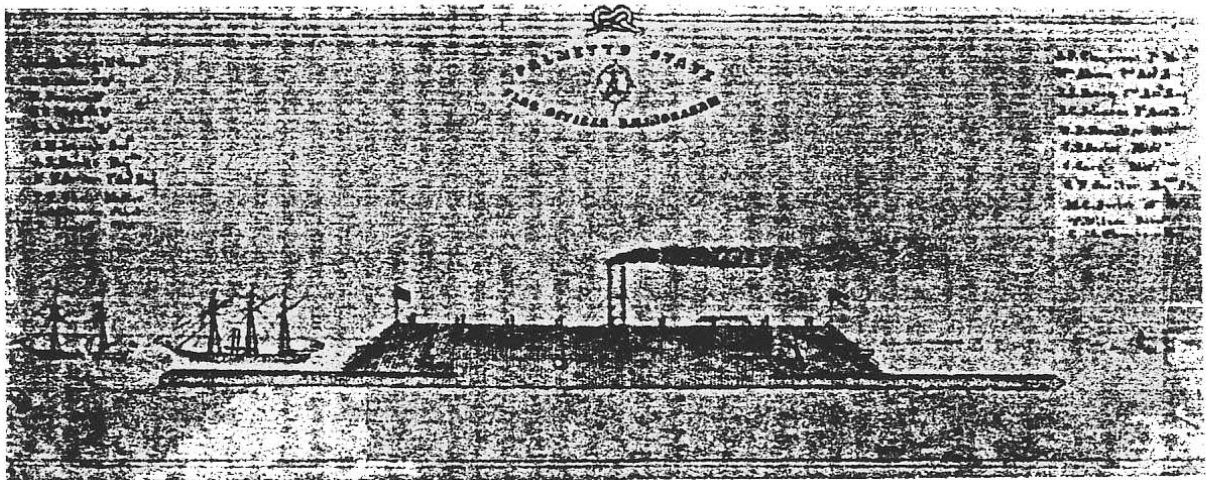
Figure 6: CSS *Palmetto State*, water color. Pilot house is also aft. Note octagonal construction of casemate. (Photo: William N. Still, *Iron Afloat*, 111: Courtesy of US Navy)

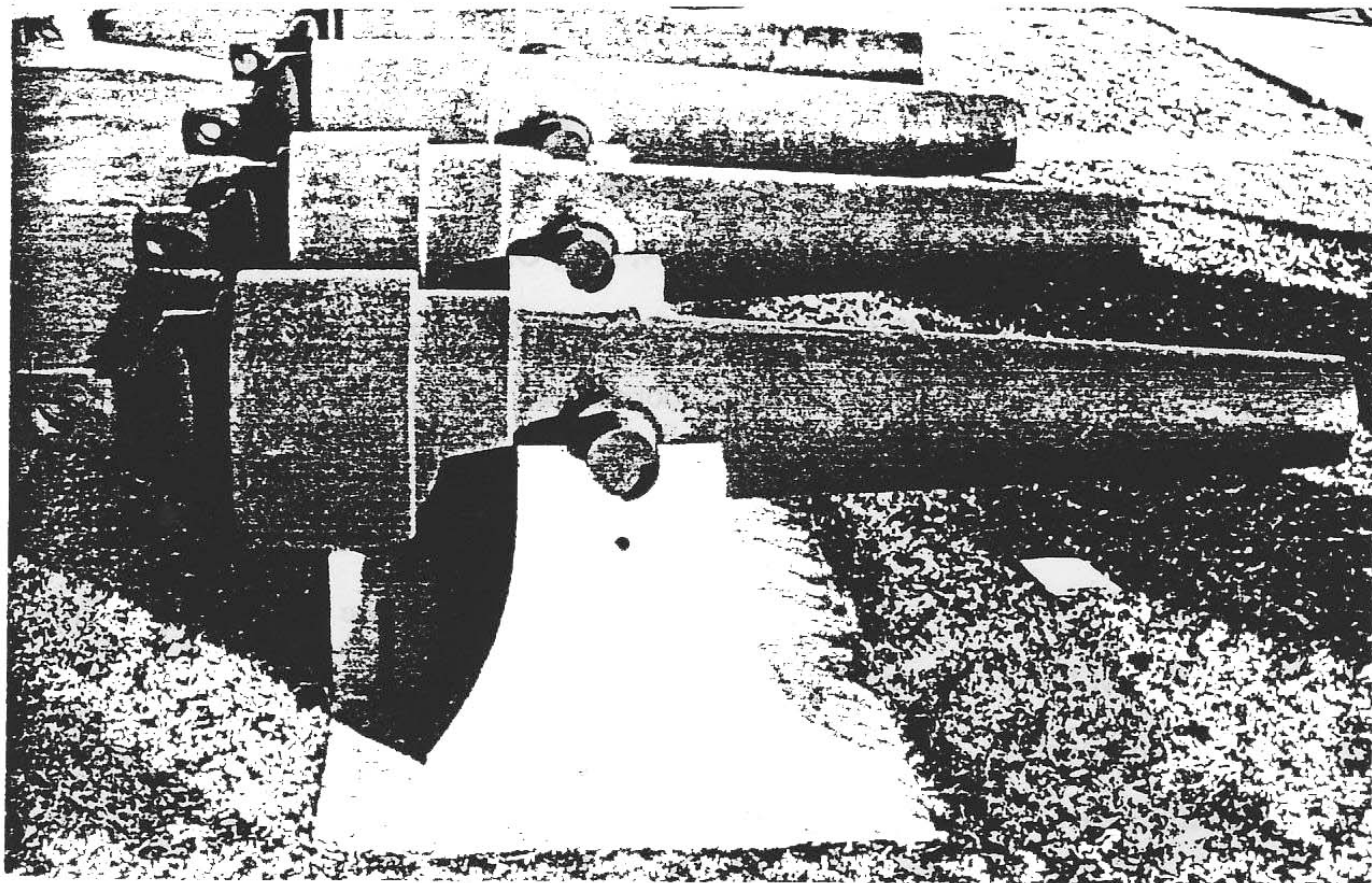
Figure 8: Brooke rifles. The *Raleigh*'s battery of four guns consisted of at least two, double banded Brooke rifles of 6.4-inch caliber. Two such weapons are shown in the foreground of this picture at the Washington Navy Yard, D.C. (Photo: Warren Ripley, *Artillery and Ammunition of the Civil War*, p. 129)

weighed 90 pounds. The *Raleigh*'s other two guns may have been 7-inch guns, also designed by Brooke.²⁰ Unfortunately, no tables have been found to suggest what the range or the penetration of either of these weapons might have been.²¹ The nearest model for comparison is an 8-inch Brooke rifle, which according to General R. S. Ripley, could throw a 100 pound shell four miles with an elevation of 20.5 degrees.²² This range, however, was severely restricted by the design of the casemate gunports. According to Gen. P. G. T. Beauregard, the elevation of the guns aboard the Charleston ironclads was less than seven degrees.²³ Their effective range was only about one and a half miles. By at least one Federal account, the *Raleigh* demonstrated a similar range.²⁴ (Brooke rifles, see Figure 8)

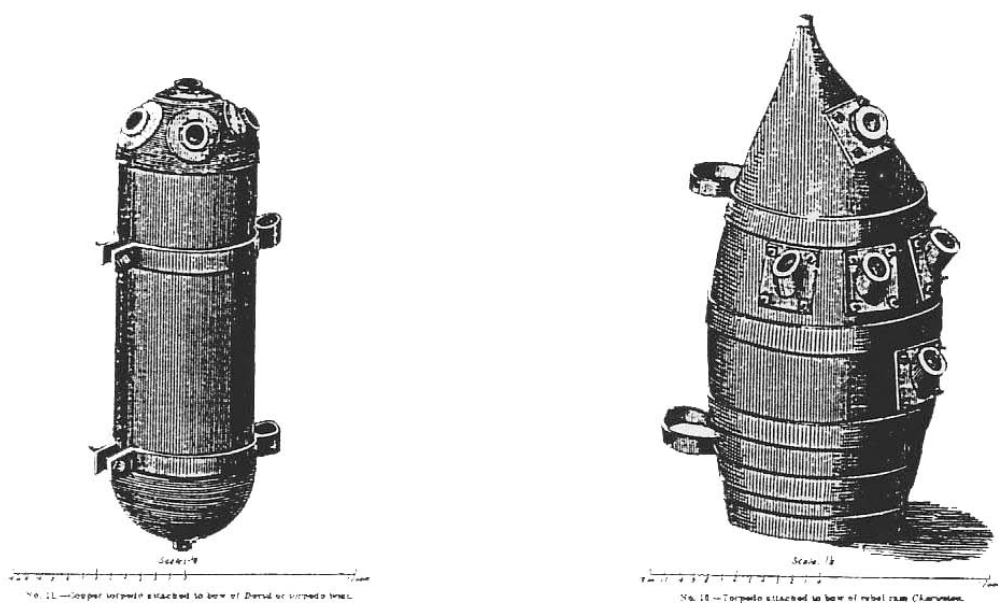
Figure 9: Spar torpedoes. The *Raleigh*'s arsenal may have included one of these, as noted by the captain of the USS *Howquah*. (*Official Records, Navies*, Ser. I, Vol. XVI, 396-397)

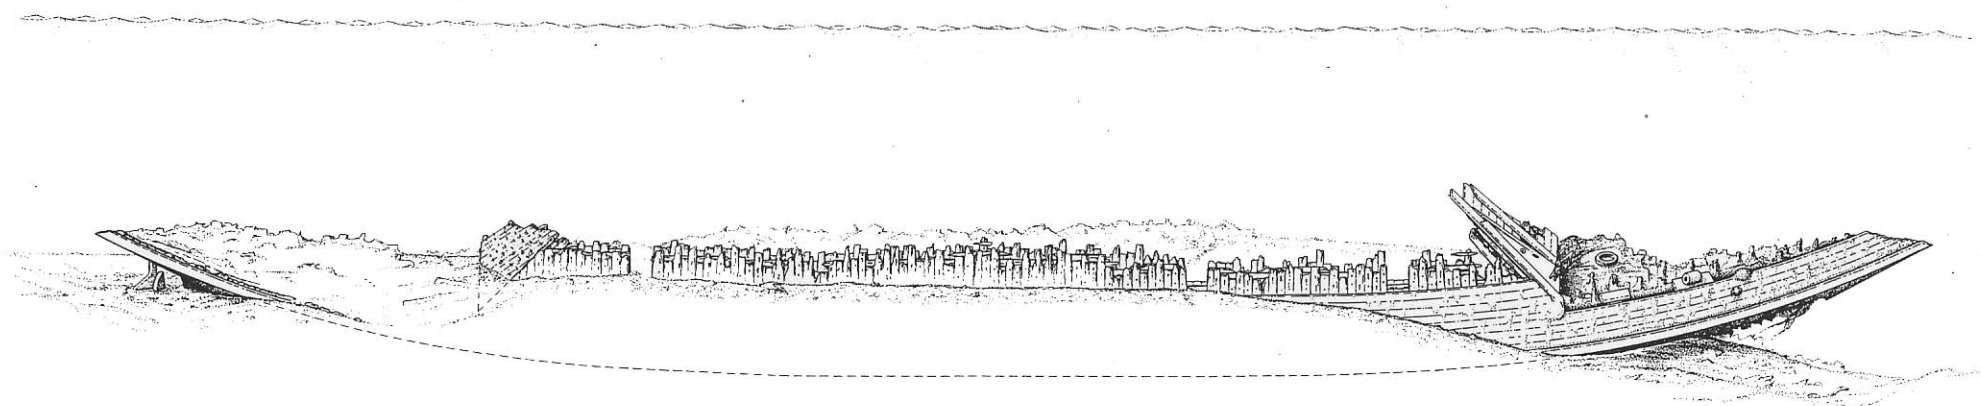
Figure 14: Horizontal Conception - Starboard Side.

Horizontal Conception - Starboard Side

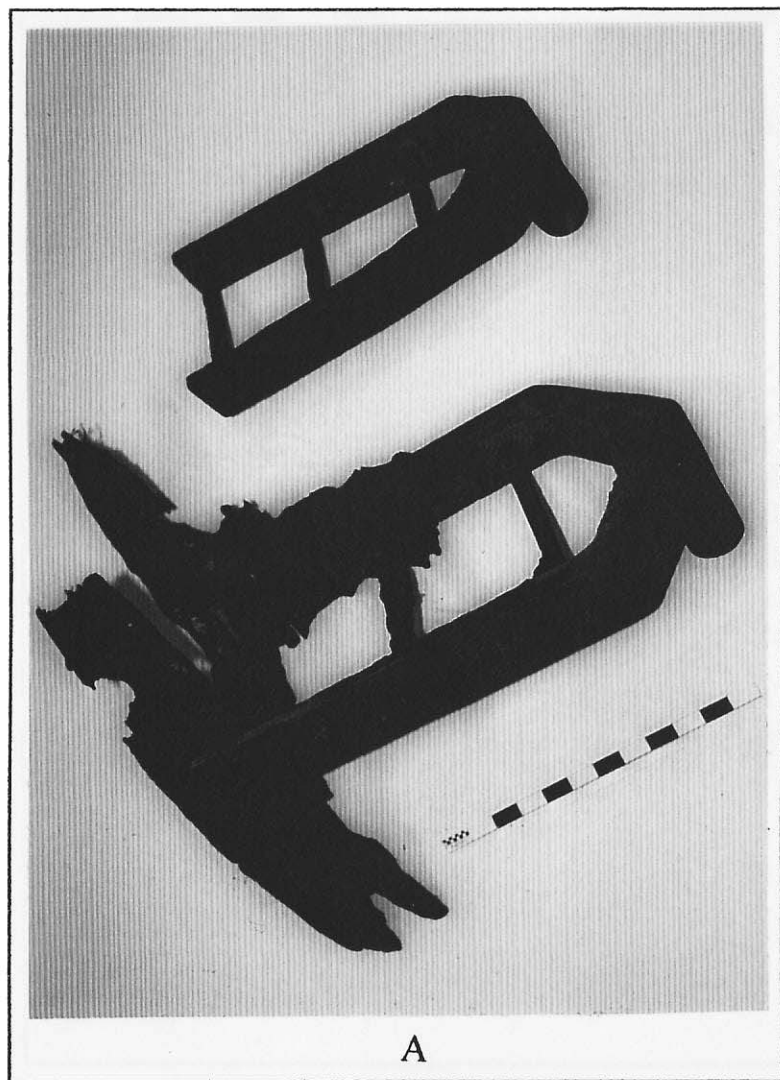
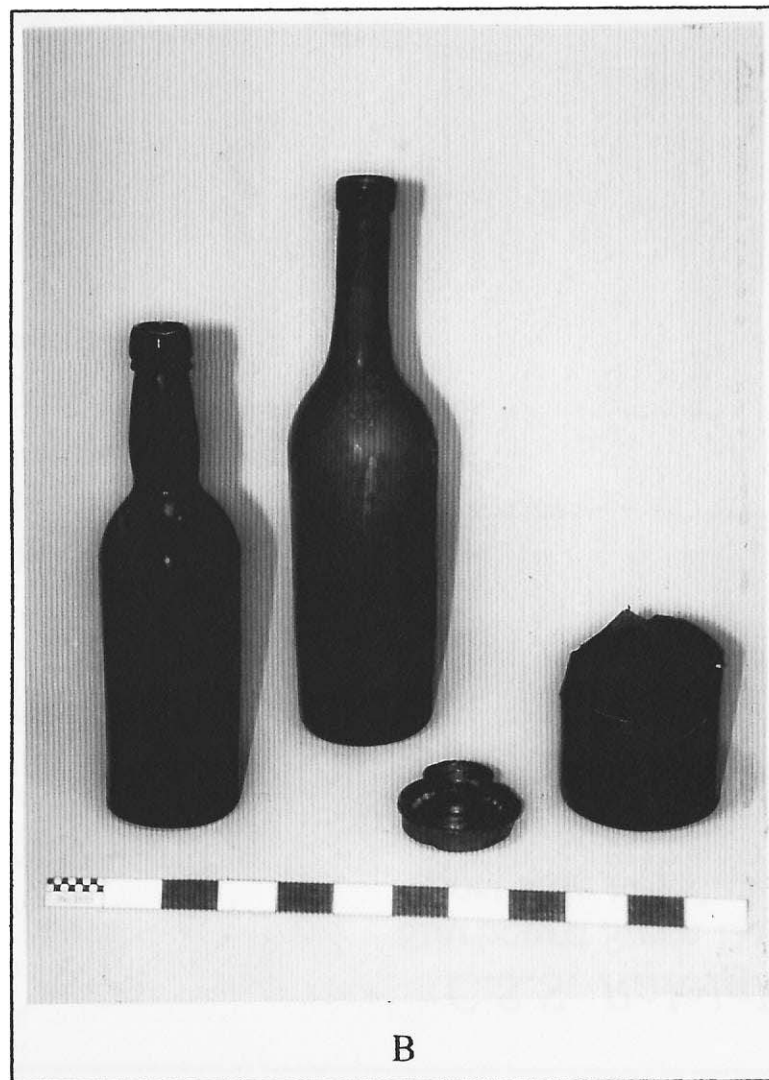
Figure 18: Artifacts. A - pintles from a lost rudder: large pintle (003-NEI-1); small pintle (003-NEI-2). B - left to right: brown bottle (003-NEI-3); green bottle (003-NEI-4); brown bottle fragment (003-NEI-5); unidentified copper fitting (003-NEI-6).

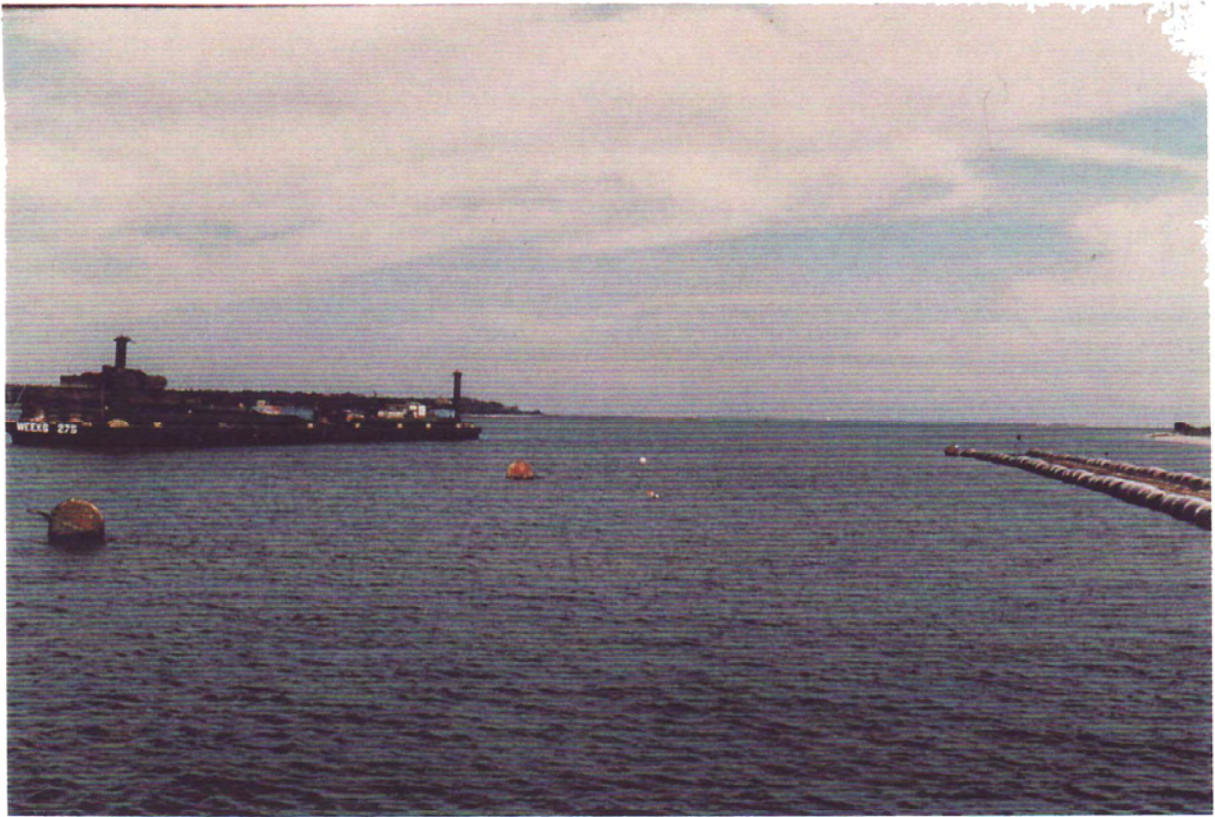
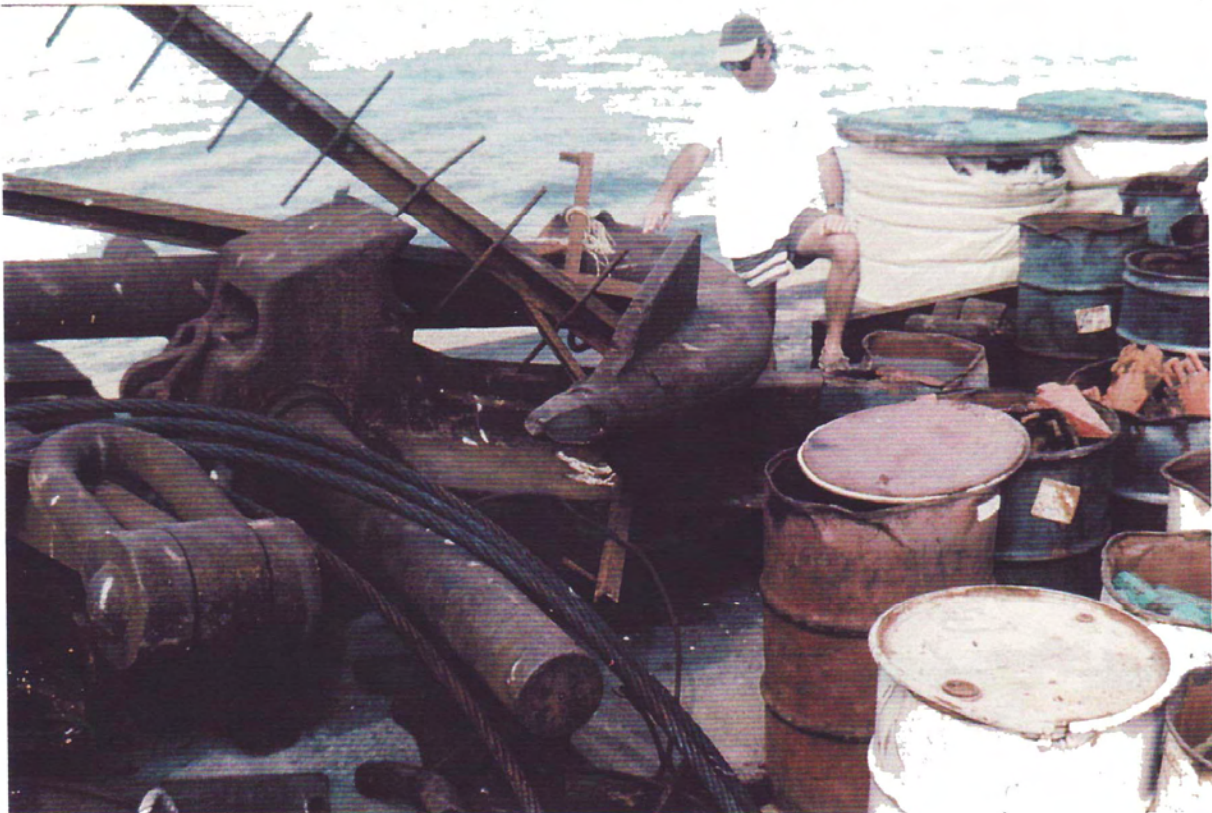
Figure 20: Above: Spud barge next to *CSS North Carolina*. The spuds missed the wreck but the bouy at center is anchored in the midship area. Below: Author's foot is on 15,000 pound anchor of the type dropped on the *North Carolina*.

compared to the *Raleigh*'s 15 foot casemate.¹⁹³ As dredging operations in the Cape Fear River move upstream, so do the spud barges and their heavy equipment. Recently, the *North Carolina* was fouled with a 15,000 pound anchor.¹⁹⁴ In its currently unmarked state, *Raleigh*'s exposure and the fouling of shrimp nets are among the lesser concerns (Figure 20).
